Port of Portland Corporate Seismic Risk Assessment Study

Final Report

May 2015

Port of Portland

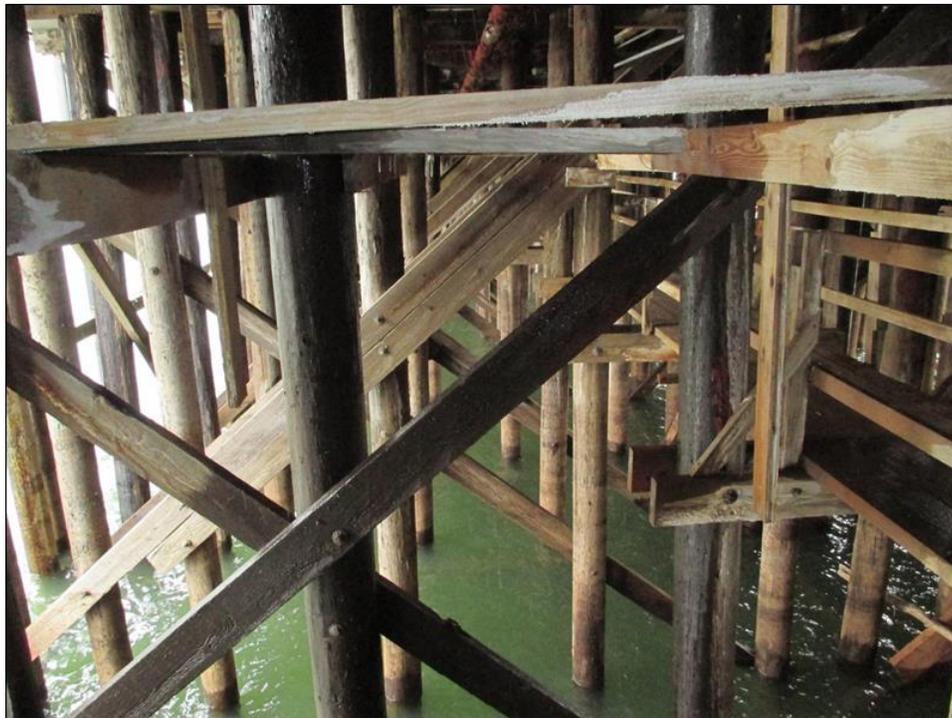
Photo 1 – Berth 410 typical timber piles and bracing configuration

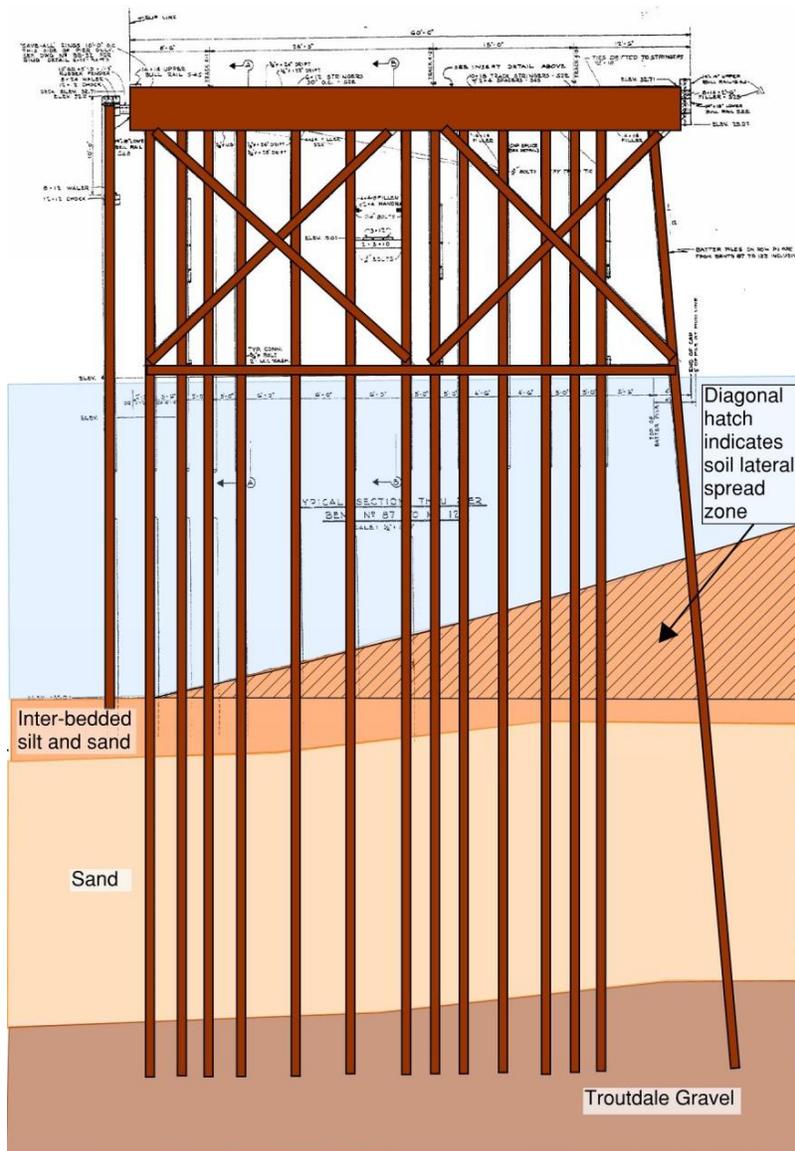
In general, the pier has a complete lateral load path. However, the performance of the structure is vulnerable due to the age, condition and lateral-load resistance capabilities of the structural elements, particularly at the lower connection of the diagonal bracing to the piles. Additionally, potential post-earthquake soil settlement and soil lateral spreading displacements at Berth 410 are significant. Figure 2 below shows a typical Berth 410 pier cross section indicating the potential zone of soil lateral spreading.

Figure 2 – Berth 410 typical pier section indicating zone of soil lateral spreading

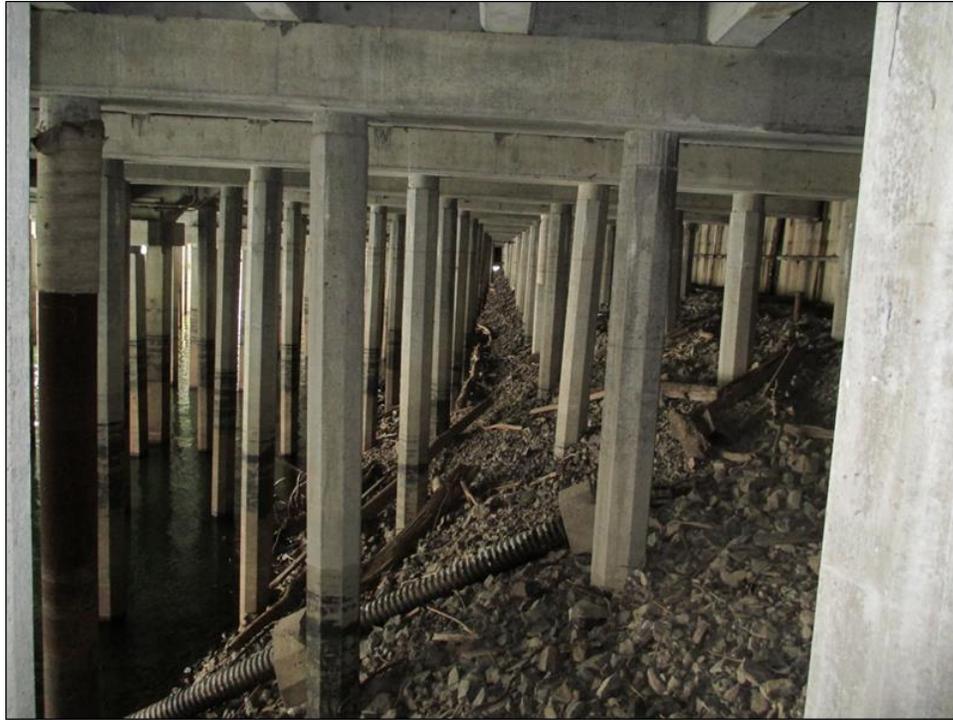
Based on the walk-through and review of the 2013 BergerABAM condition survey, the wharf structure is judged to be in fair condition, with minor damage to the piles, and cracking and spalls in the concrete pile caps and deck.

Photo 2 – Berth 411 typical concrete piles and pile caps arrangement

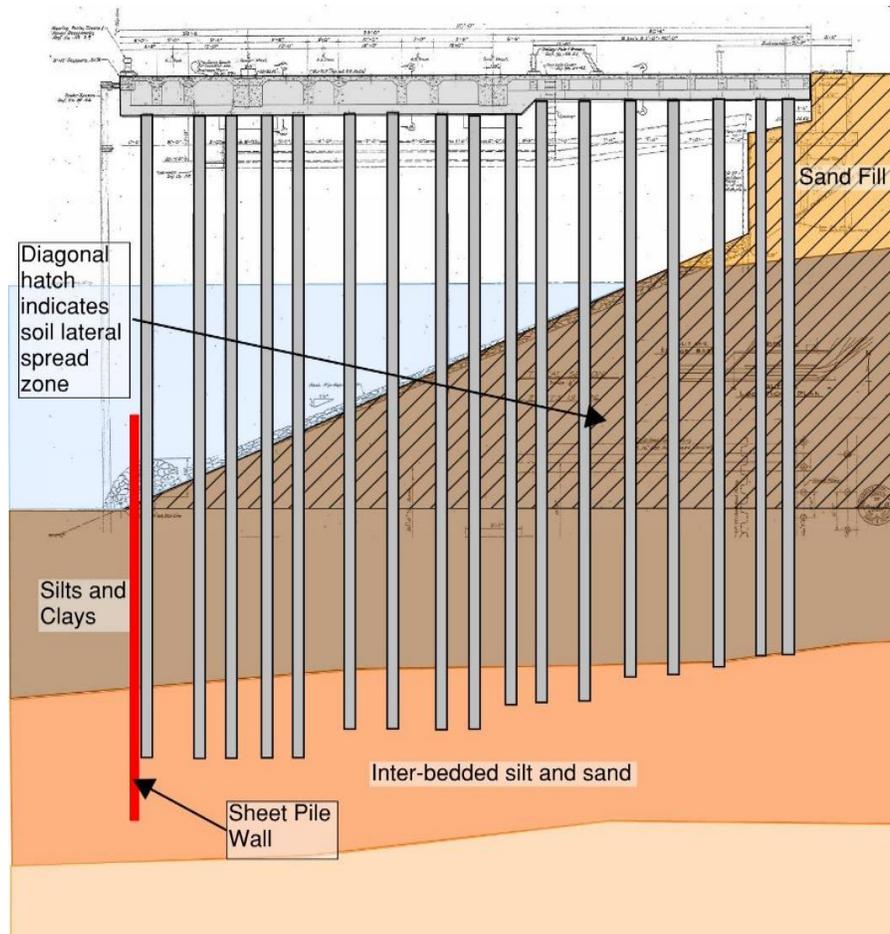
Post-earthquake soil settlement and soil lateral spreading displacements are estimated to be significant at Berth 411. Figure 4 below shows a typical Berth 411 cross section indicating the potential zone of soil lateral spreading.

Figure 4 – Berth 411 typical wharf section indicating zone of soil lateral spreading

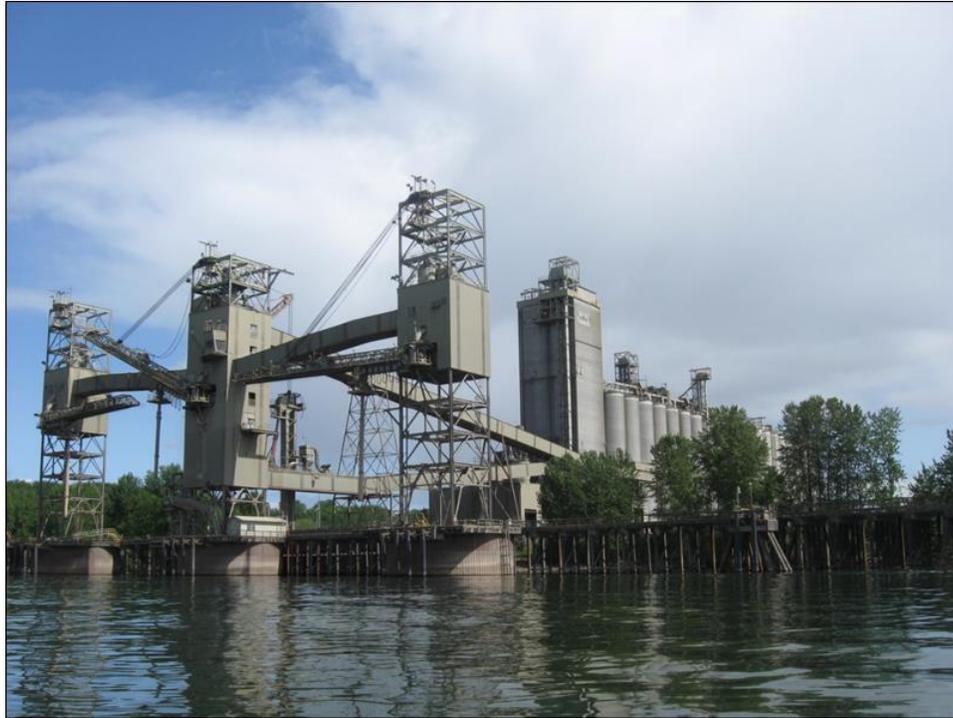
The general condition of the pier structure was not verified.

Photo 3 – Berth 501 dock and shiploader towers general arrangement

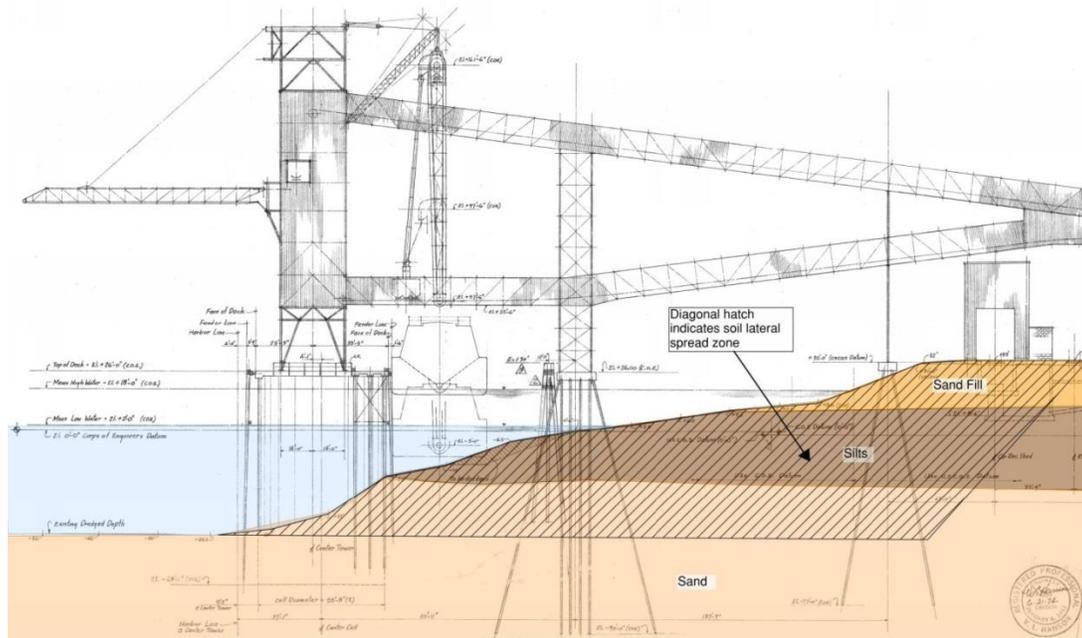
Closer to shore, a bridge tower supports the conveyers for the shiploading towers and is founded on an isolated concrete dolphin on steel piles. The dolphin is highly susceptible to the lateral spreading displacements and could undergo large, permanent deformations after the earthquake. Conveyor bridges span from the tower to the shiploader towers, and any deformation of the conveyor tower and bridges could result in the transfer of large seismic forces.

Figure 6 – Berth 501 dock section indicating zone of soil lateral spreading

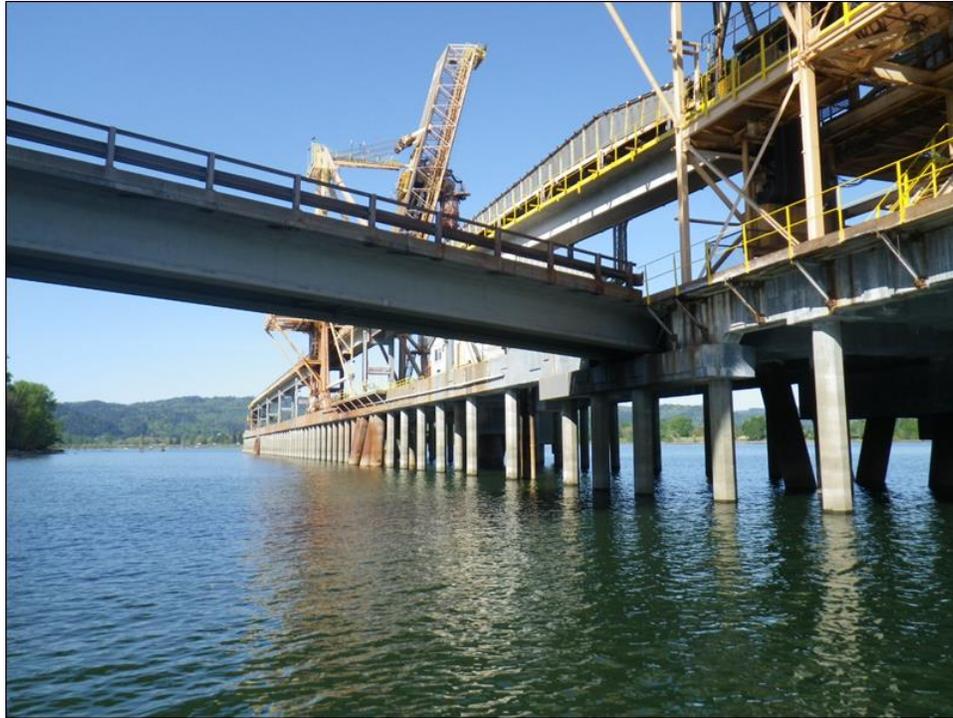
The overall condition of the pier appeared to be satisfactory. Several concrete structural members exhibited cracking and spalling with some rust staining.

Photo 4 - Berth 503 dock and trestle bridge

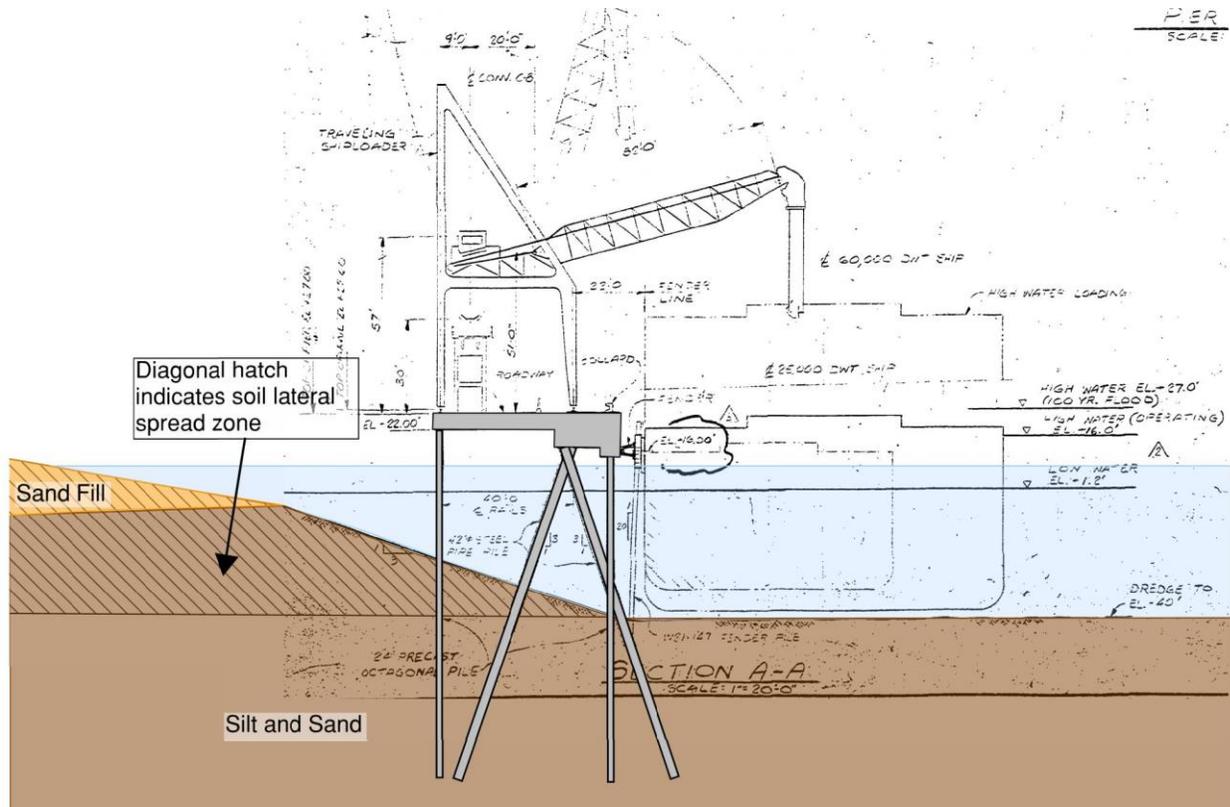
Soil lateral spreading displacements are expected to be significant at Berth 503. Figure 8 below shows a typical Berth 503 cross section indicating the potential zone of soil lateral spreading.

Figure 8 – Berth 503 dock section indicating zone of soil lateral spreading

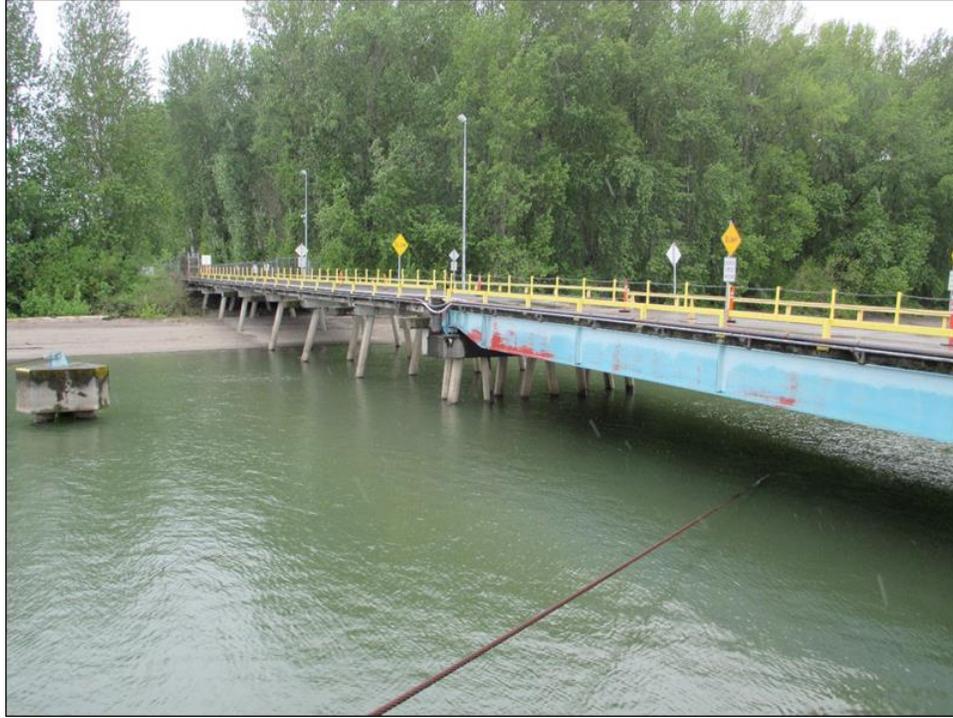
The overall condition of the dock and approach trestle appeared to be good.

Photo 5 – Berth 601 trestle and access ramp

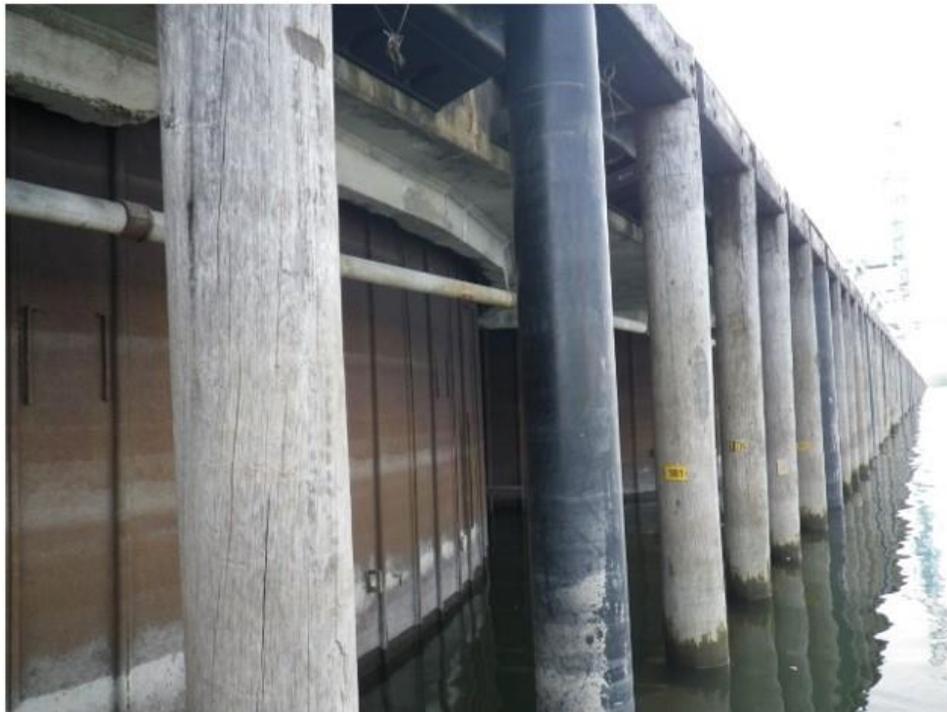
The overall condition of the wharf was considered satisfactory to good in 2013.

Photo 6 – Berth 604/605 cellular sheet piles
