**Subject: Cultural Resources Risk Assessment for the Terminal 2 Mass Timber EDA Project, Portland, Oregon**

Port of Portland, Mass Timber EDA Grant

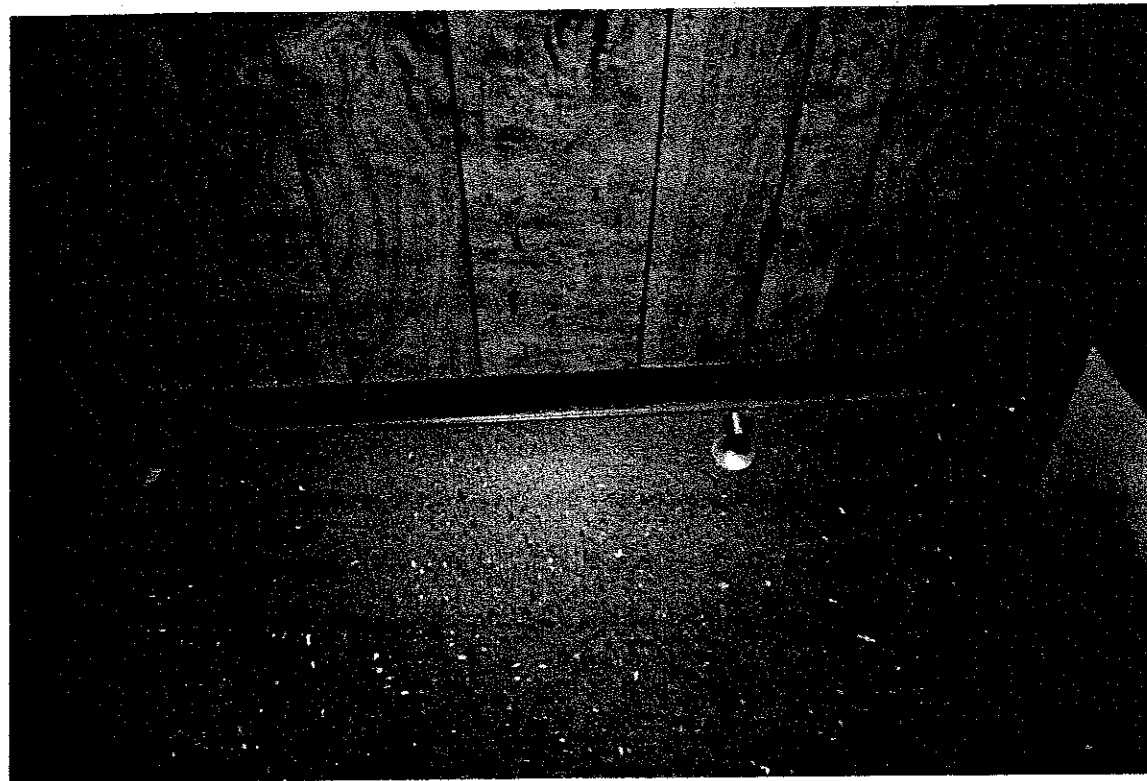
PHOTO 2: VINYL FLOOR TILE/MASTIC (1), (2); LOCATED IN THE GEARLOCKER OFFICES, RESTROOM, AND LUNCH ROOM; BOTH MATERIALS TESTED POSITIVE; GOOD CONDITION.

CODE	MATERIAL	ANALYSIS	LOCATION	LAB
08415.90-051	Vinyl Floor Tile (2)	2% Chrysotile (dark brown tile) 12% Chrysotile (black mastic)	2d floor big office 12" brown tile w/brwn & white strks	PBS Laboratory
08415.90-052	Vinyl Floor Tile	1% Chrysotile (brown tile) 3% Chrysotile (yellow mastic)	2d floor little office 12" brown tile w/brwn & white strks	R.J. Lee Group
08415.90-053	Covebase/Mastic (1)	No Asbestos Detected (both layers)	2d floor little office 4" brown	PBS Laboratory
08415.90-054	Covebase/Mastic (2)	No Asbestos Detected	2d floor big office 4" cream	R.J. Lee Group
08415.90-055	Vinyl Floor Tile (01)	1% Chrysotile (black tile) 10% Chrysotile (black mastic)	restroom 12" black tile w/white streaks	PBS Laboratory
08415.90-056	Vinyl Floor Tile (1)	<1% Chrysotile (black tile) 5% Chrysotile (black mastic)	lunchroom 12" black tile w/white streaks	R.J. Lee Group
08415.90-057	Covebase/Mastic (3)	No Asbestos Detected (both layers)	restroom; 4" black	PBS Laboratory

RECOMMENDED COURSE OF ACTION	SUBTOTAL	\$ -0-
REMOVE ALL ASBESTOS PRIOR TO DEMOLITION	TOTAL	\$2,484

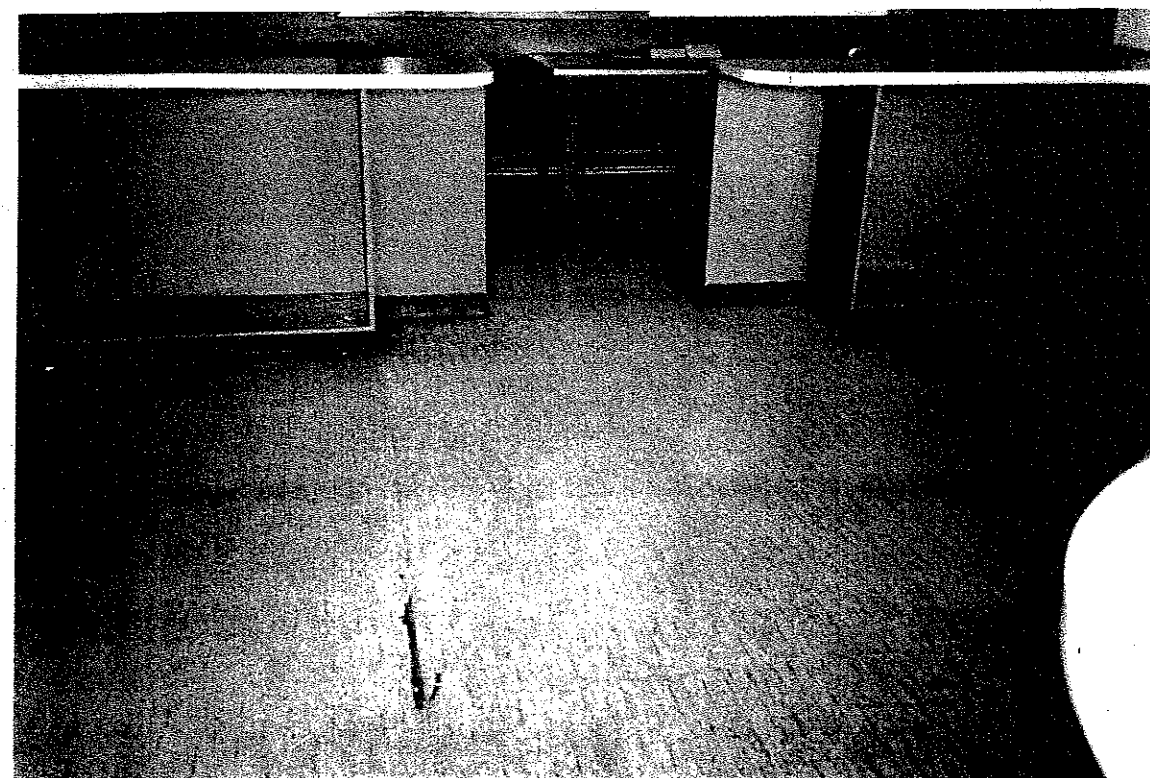
PHOTO 2: VINYL FLOOR TILE/MASTIC; 12" WHITE WITH BLACK SPECKS; LOCATED THROUGHOUT THE FIRST FLOOR OF THE OFFICE; CONTAINS ASBESTOS; FAIR CONDITION.

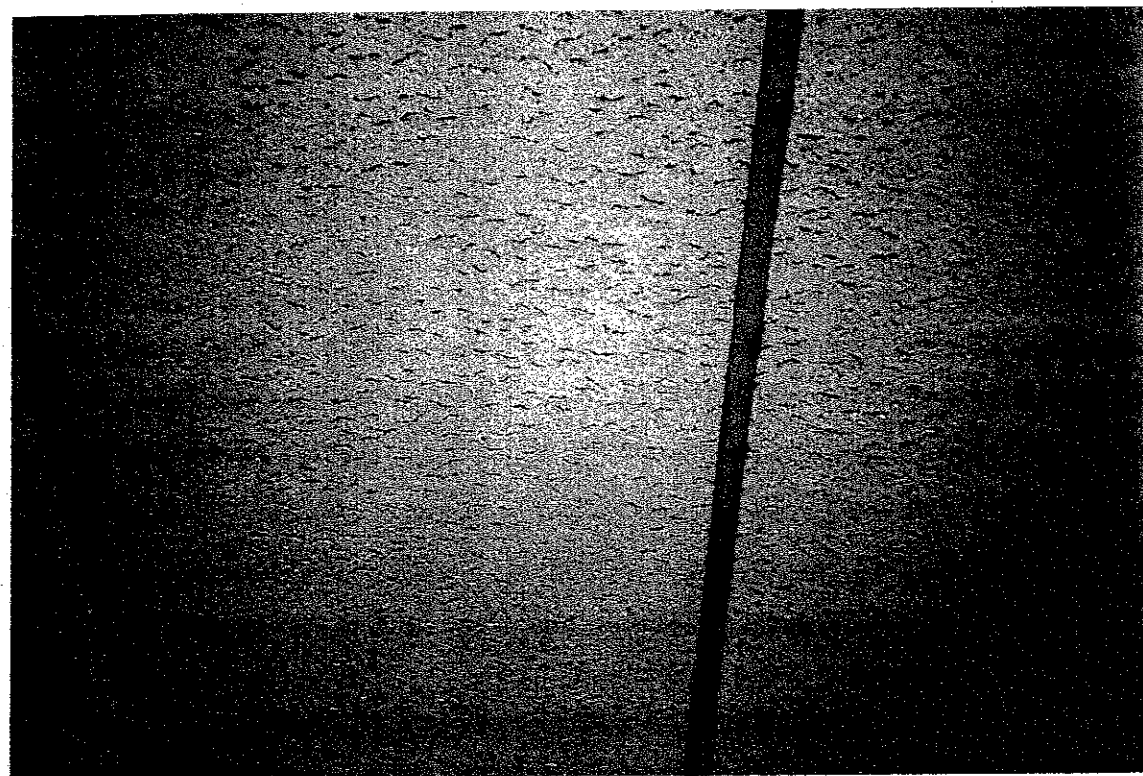
PHOTO 3: LAY-IN CEILING TILE; 2' X 4' RANDOM PIN PERF WITH FISSURES; LOCATED THROUGHOUT WAREHOUSE 205 OFFICE; TESTED POSITIVE; GOOD CONDITION.

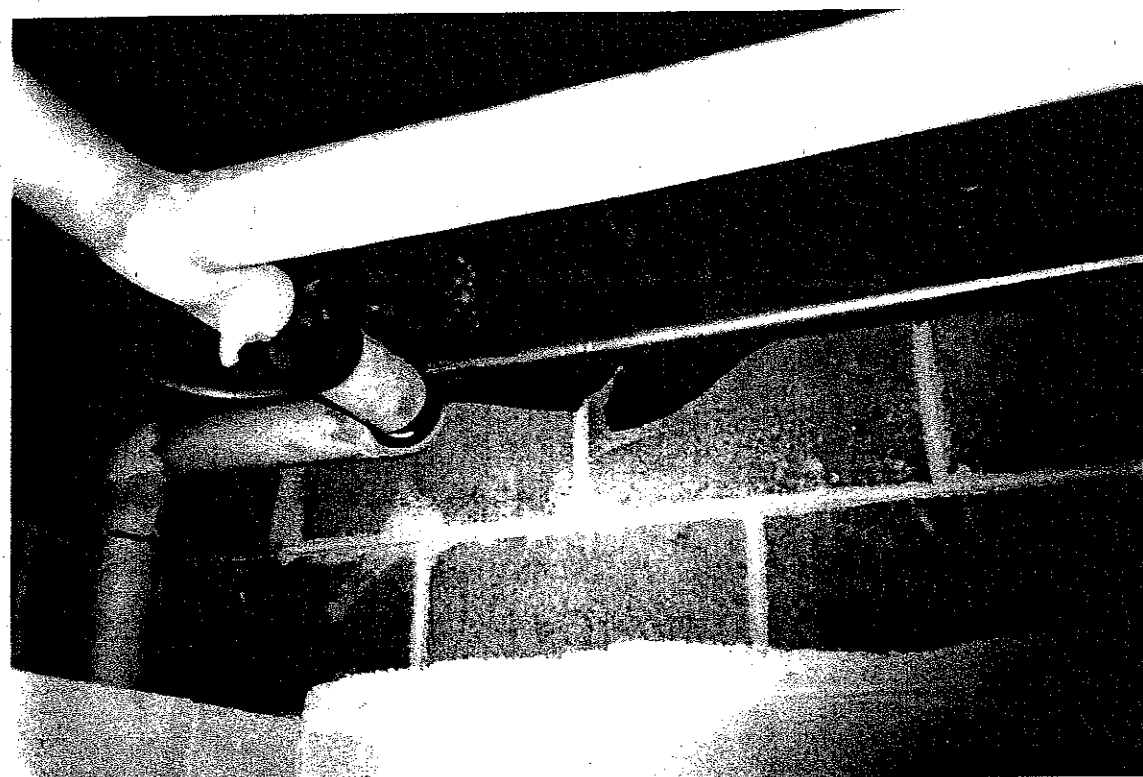
PHOTO 4: HARD FITTINGS ON FIBERGLASS; LOCATED ABOVE THE BASEMENT LAY-IN CEILING TILE; TESTED POSITIVE FOR ASBESTOS; GOOD CONDITION.

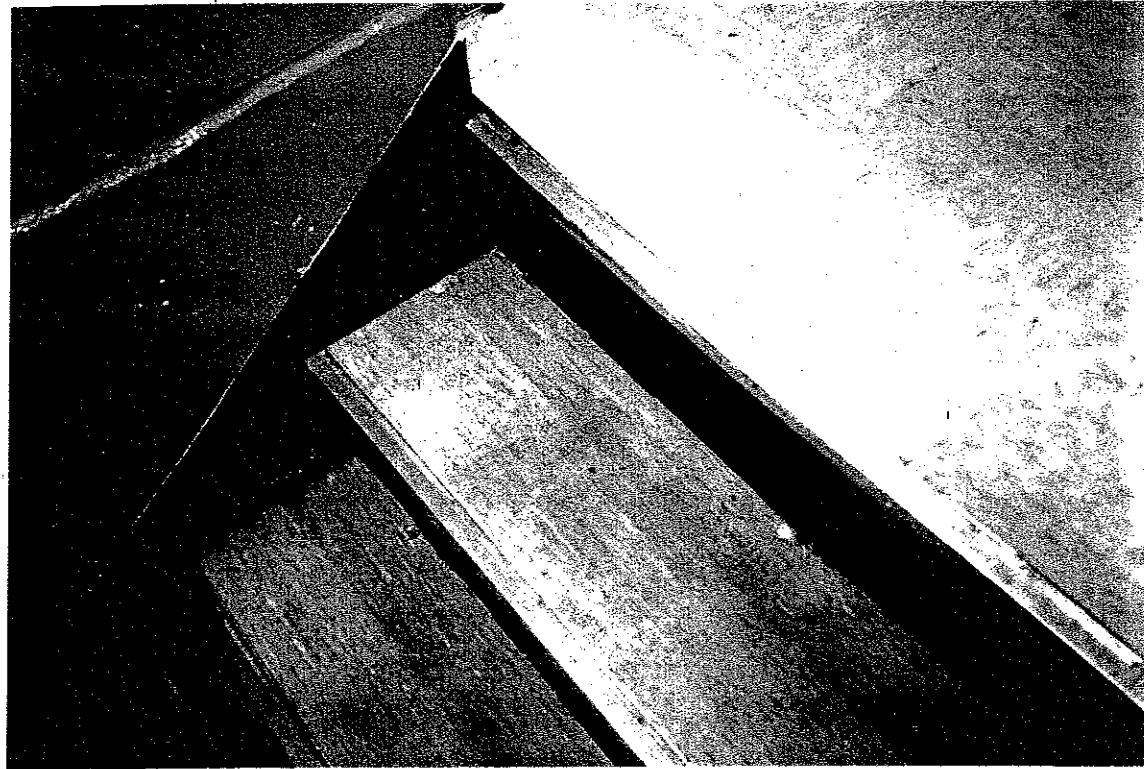
PHOTO 5: VINYL STAIR COVING; BLACK; LOCATED ALONG STAIRWELL WALLS IN WAREHOUSE 205 OFFICE; CONTAINS ASBESTOS; GOOD CONDITION.

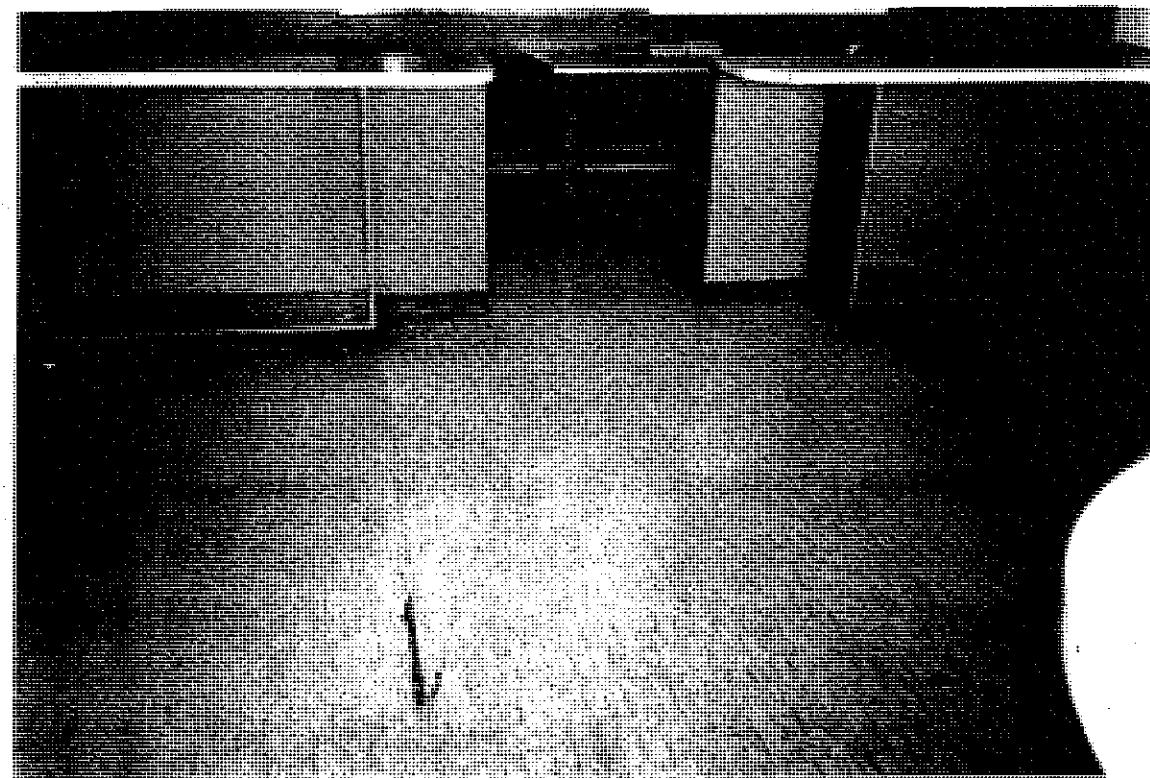
PHOTO 2: VINYL FLOOR TILE/MASTIC; 12" WHITE WITH BLACK SPECKS; LOCATED THROUGHOUT THE FIRST FLOOR OF THE OFFICE; CONTAINS ASBESTOS; FAIR CONDITION.

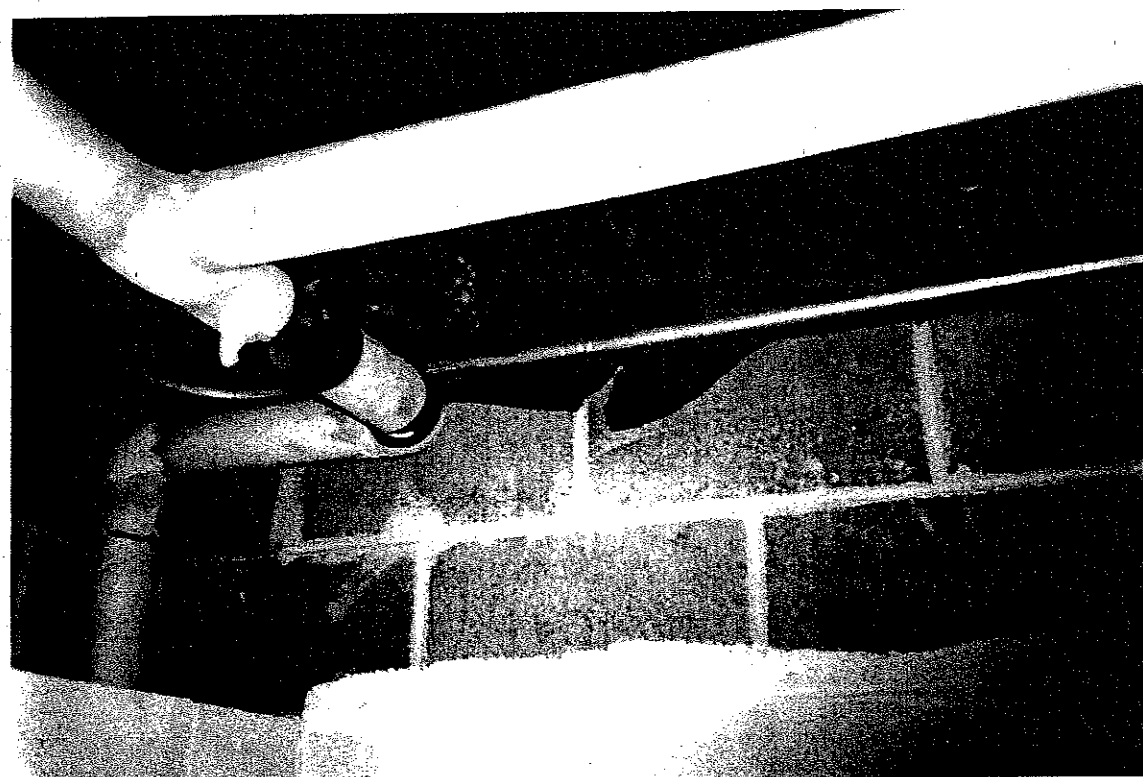
PHOTO 4: HARD FITTINGS ON FIBERGLASS; LOCATED ABOVE THE BASEMENT LAY-IN CEILING TILE; TESTED POSITIVE FOR ASBESTOS; GOOD CONDITION.

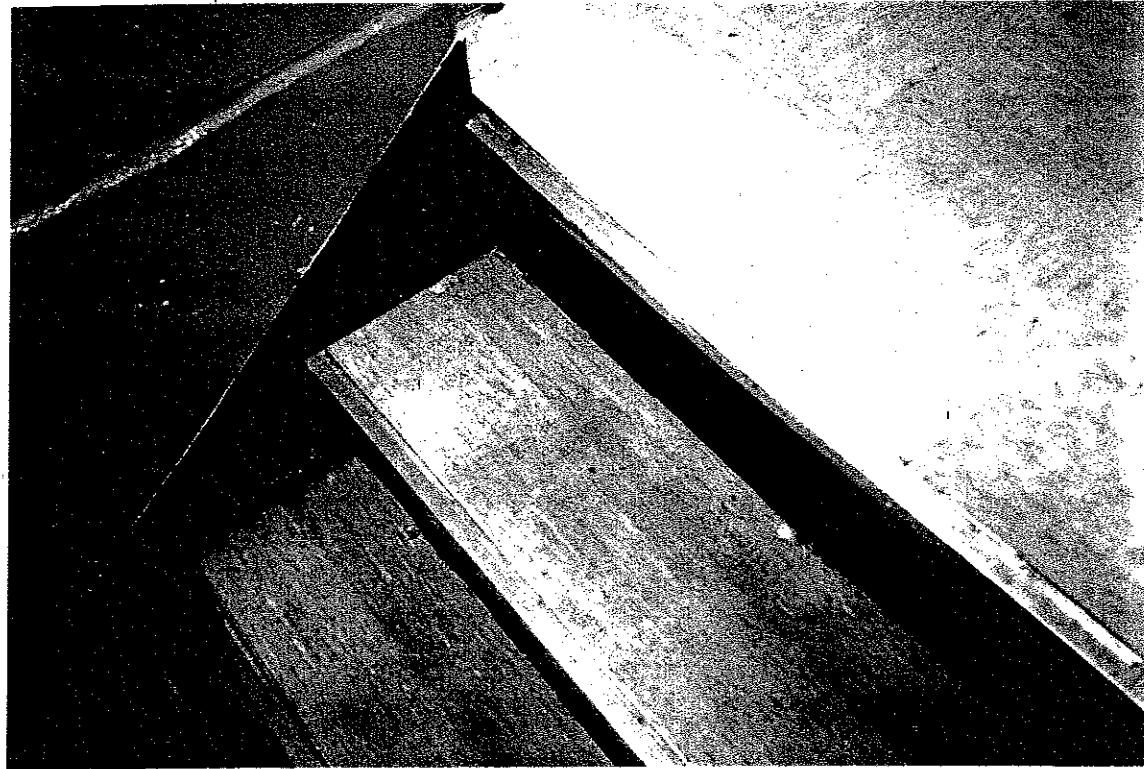
PHOTO 5: VINYL STAIR COVING; BLACK; LOCATED ALONG STAIRWELL WALLS IN WAREHOUSE 205 OFFICE; CONTAINS ASBESTOS; GOOD CONDITION.
