Port of Portland Corporate Seismic Risk Assessment Study

Final Report

May 2015

Port of Portland

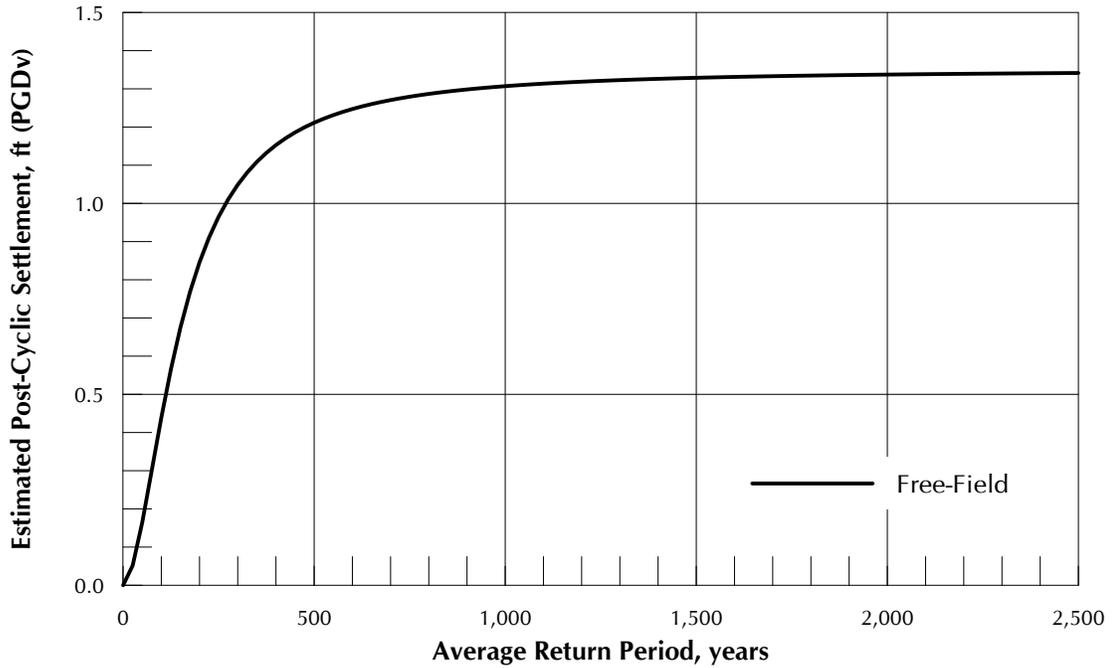
Terminal 6, CDC Warehouse

TERMINAL 6, CDC WAREHOUSE AND ELECTRICAL SHOP PERMANENT GROUND DEFORMATION VS AVERAGE RETURN PERIOD

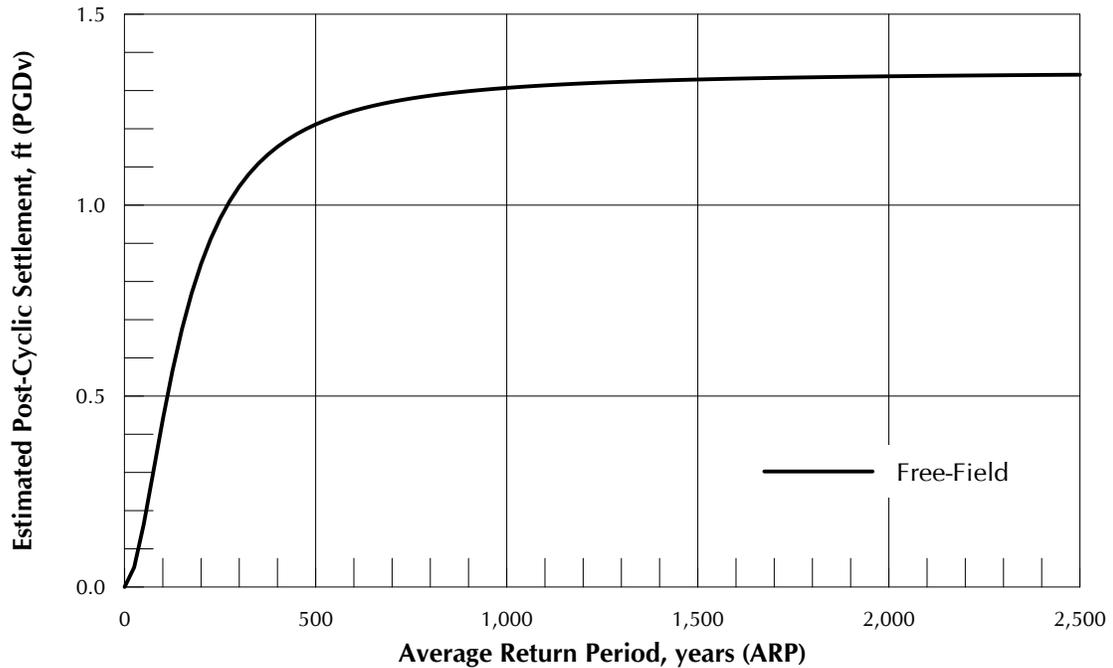
Terminal 6, Electrical Shop

Note: Additional foundation settlement is not anticipated at the 72-yr hazard level. To estimate building settlement at return periods greater than 72 yrs, add 0.5 in. to the free-field settlement.

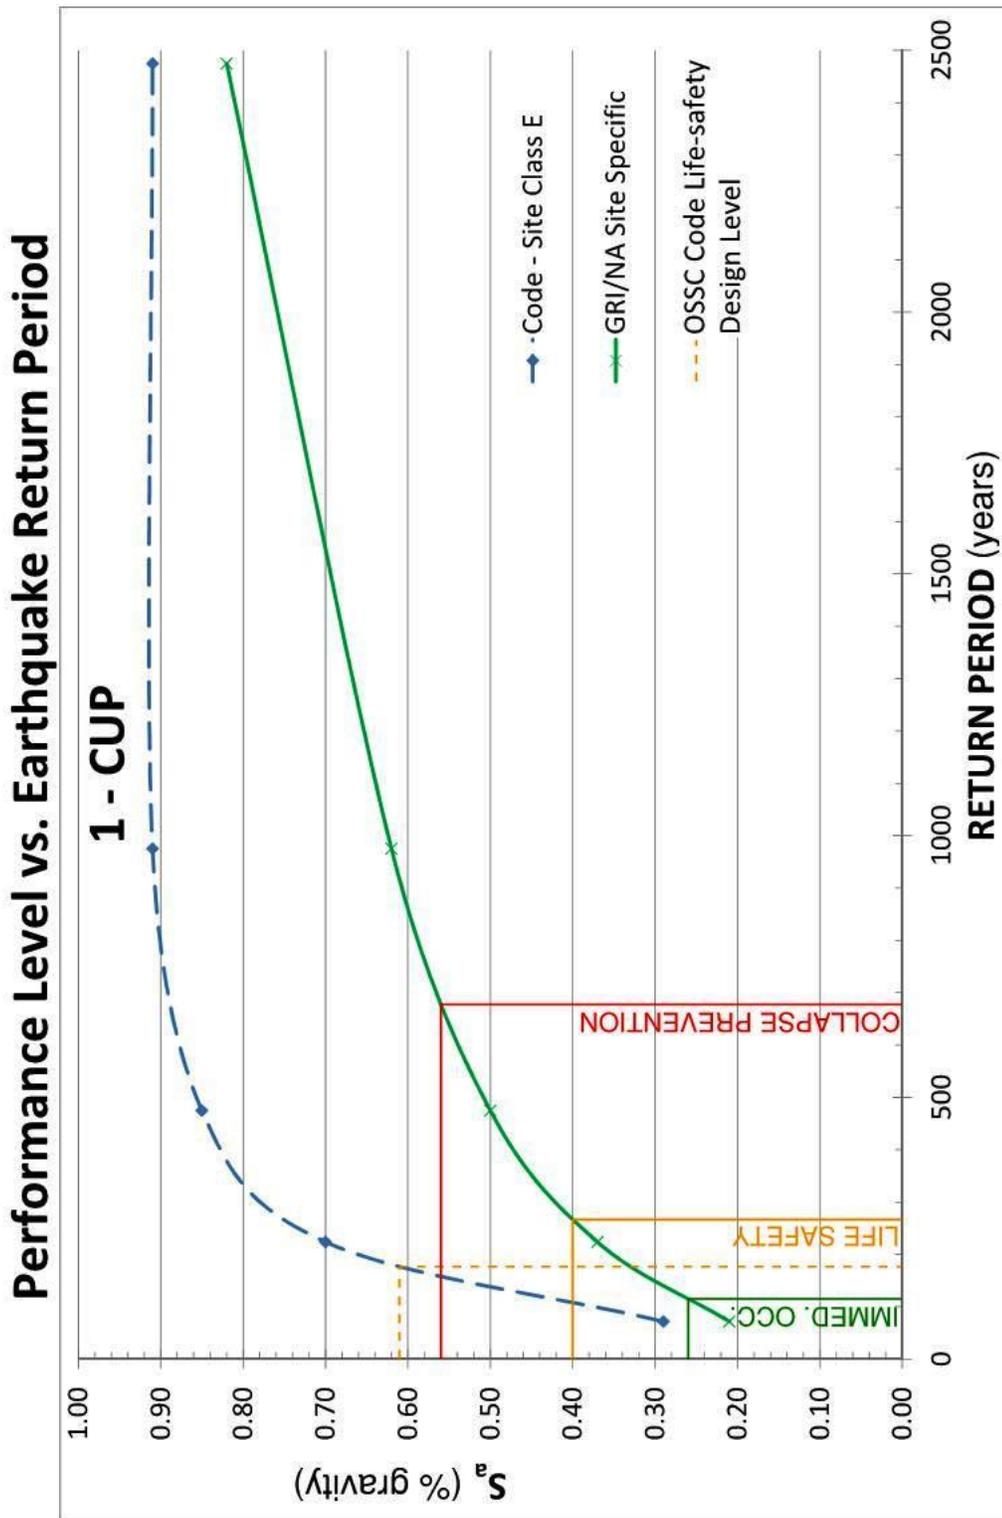
Figure 5

General Seismic Performance: The CUP design under the 1994 Code lacks the current Code requirements for ductile systems and detailing. The Code has increased the required design force for a steel ordinary braced frame substantially, resulting in the design force being between 65% and 87% of current Code requirements. The lack of ductile detailing in the lateral elements is expected to result in greater localized damage. Even with a relatively flexible roof diaphragm, the disparity in systems (cable tension bracing, HSS concentric bracing, and steel truss moment frames) is likely to result in undesirable distributions of lateral force. The cable braces and moment frames may see deflections exceeding those desirable for rigid building attachments to stiff exterior masonry work, and for glazing systems, unless properly detailed for the larger deflections, especially to achieve Immediate Occupancy. The exterior masonry walls appear especially susceptible due to the thin sections and relative lack of ductility.

Note: Performance does not include the effects of liquefaction.

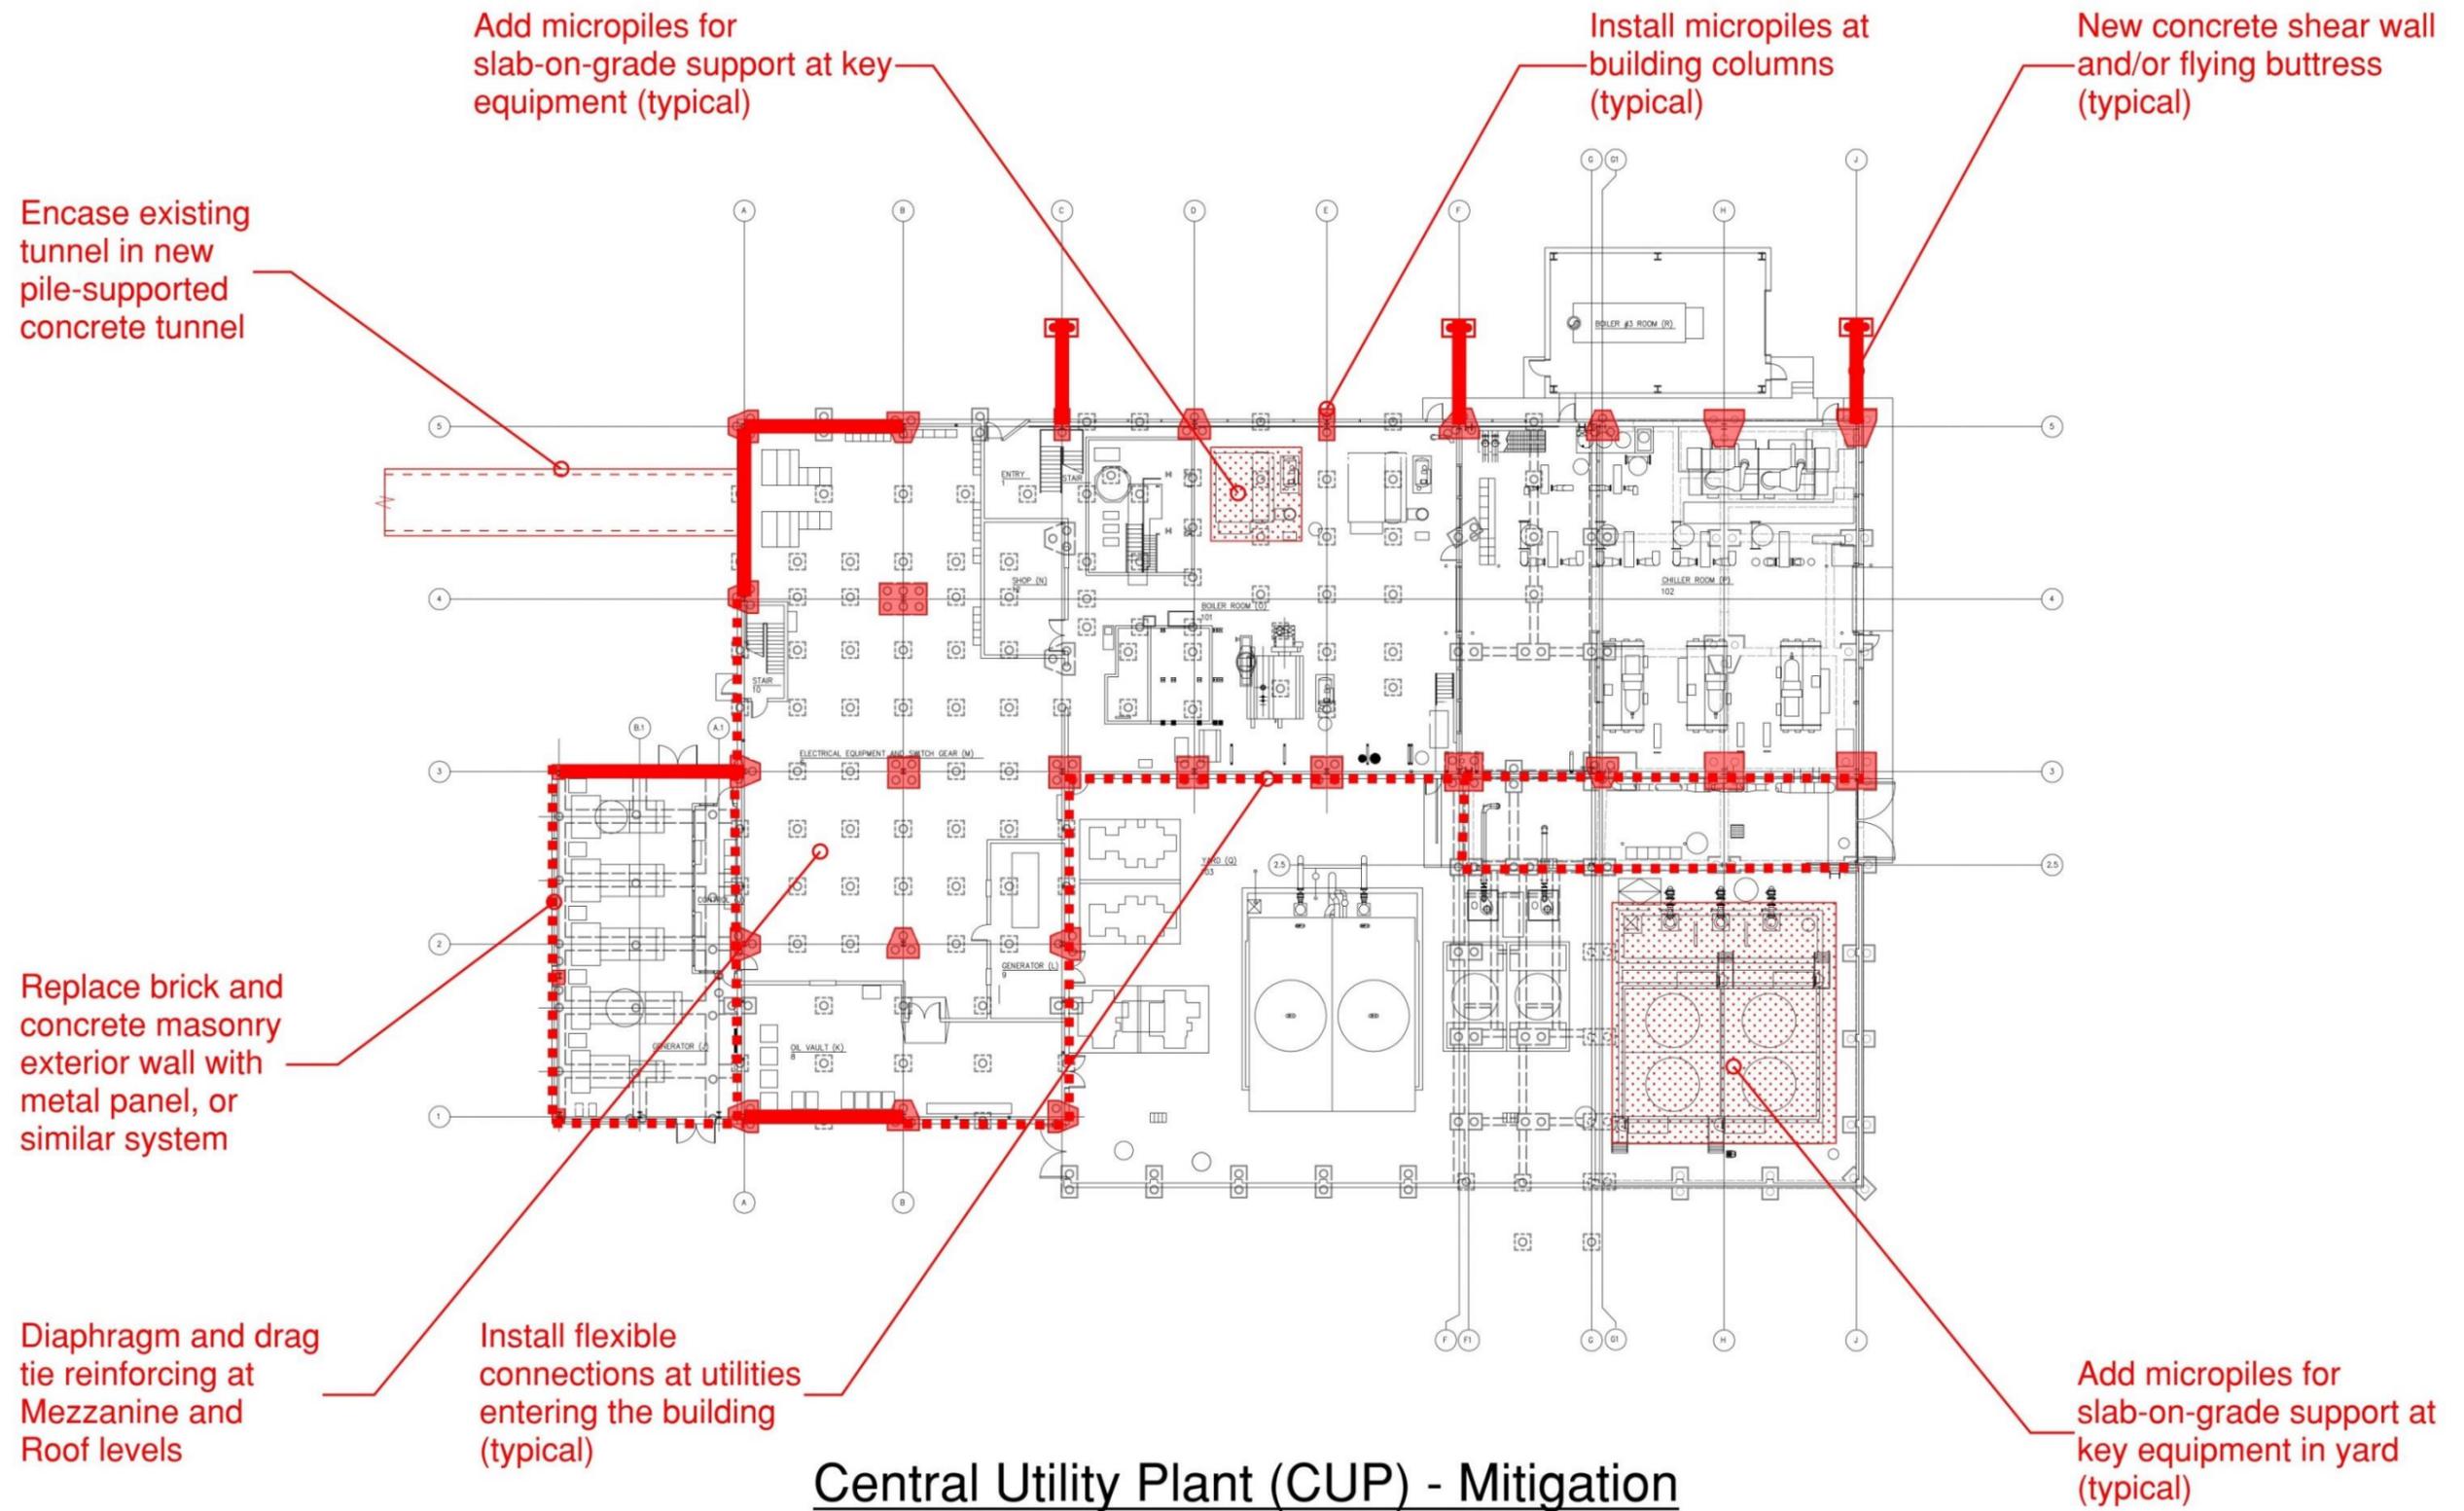
Figure 6

Central Utility Plant (CUP) - Mitigation

Construction Cost Estimate: \$16,000,000.

Next Steps: Detailed geotechnical, structural, and MEP assessments to verify the liquefaction effects, site response spectra, and assess MEP systems that are critical for Immediate Occupancy. Refined assessments to determine the preferred mitigation scheme.

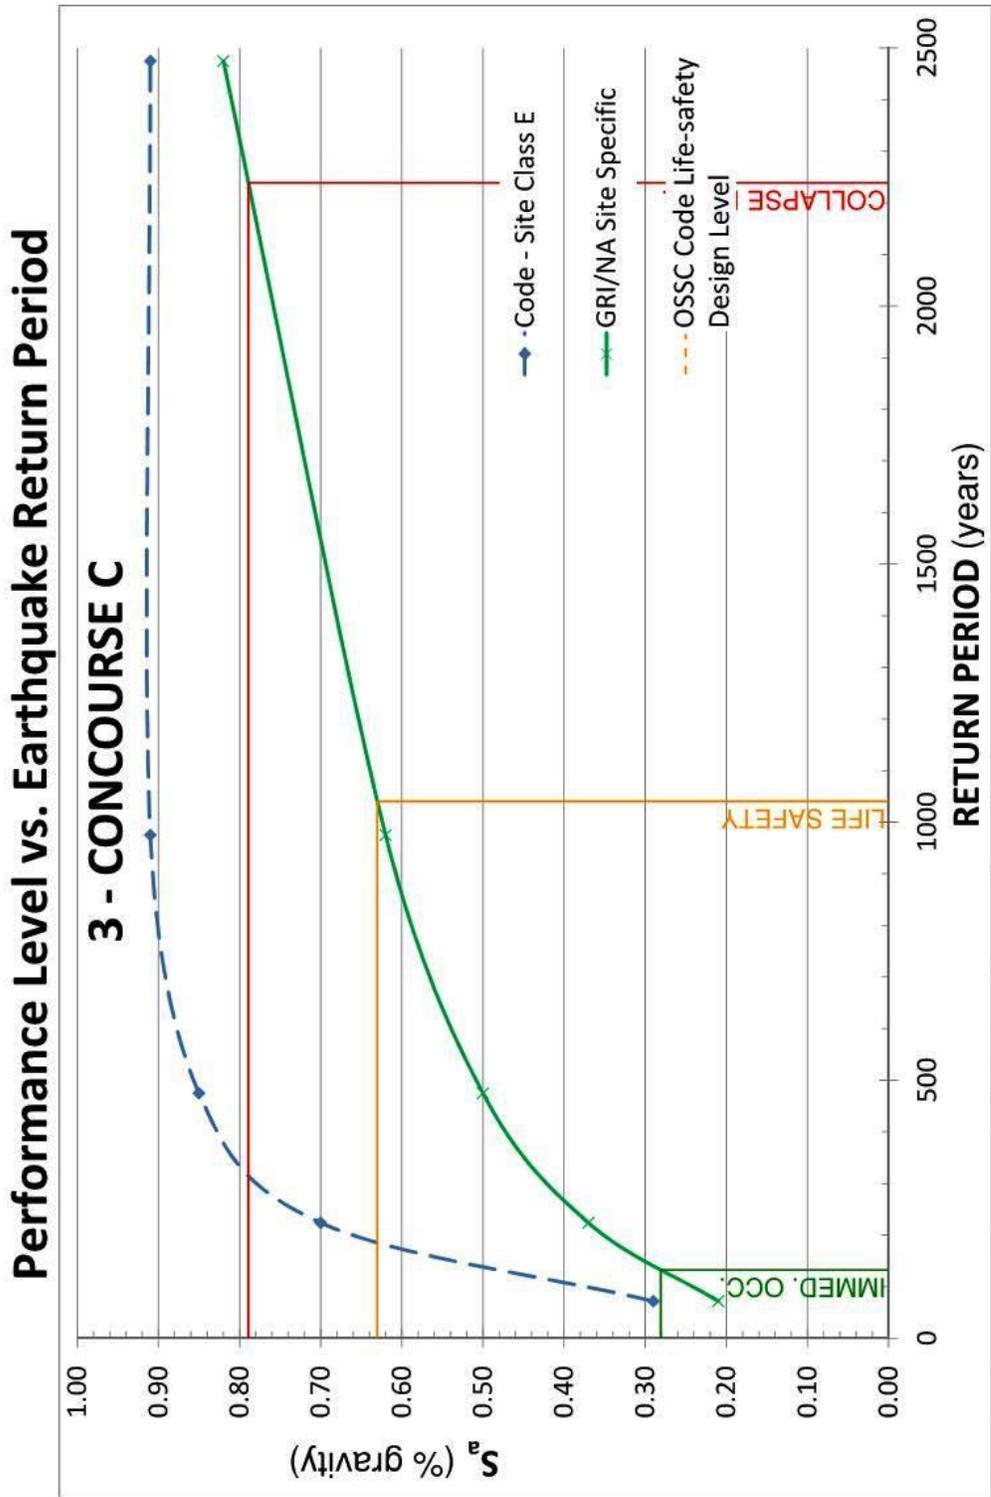
Figure 7

The evaluation of the existing structure using ASCE 41 performance criteria and site specific response spectra developed for this study, results in the following estimates of return period earthquake for the three performance levels considered (without consideration of liquefaction effects) as shown in Figure 7:

Note: Performance does not include the effects of liquefaction.

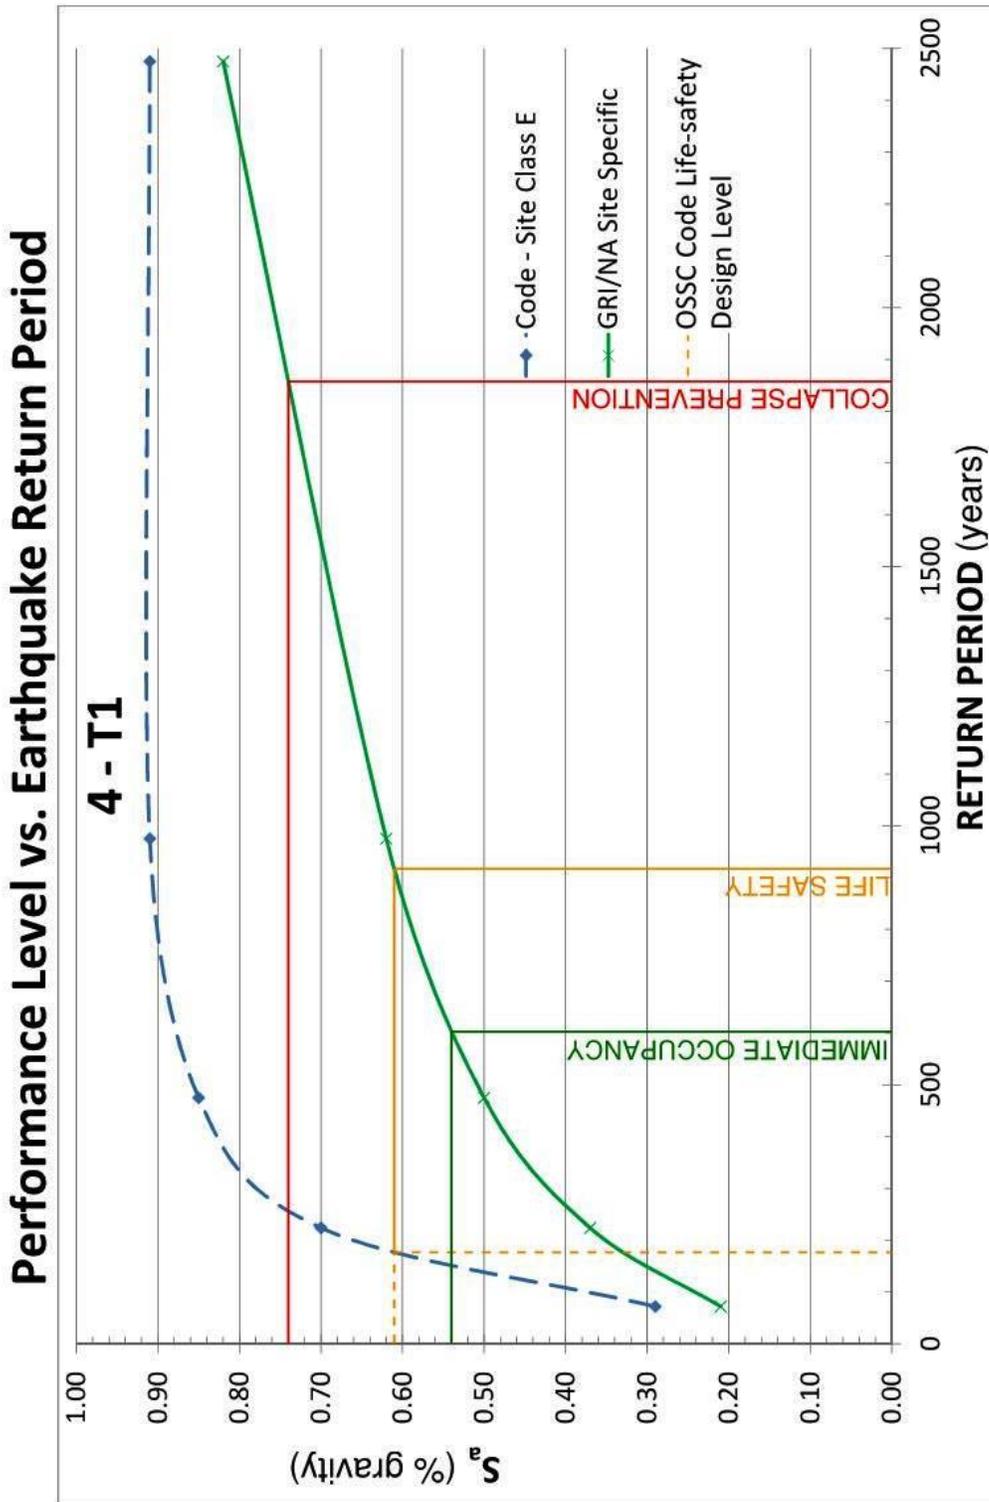
Figure 9

The evaluation of the existing structure using ASCE 41 performance criteria and site specific response spectra developed for this study, results in the following estimates of return period earthquake for the three performance levels considered (without consideration of liquefaction effects) as shown in Figure 9:

Note: Performance does not include the effects of liquefaction.

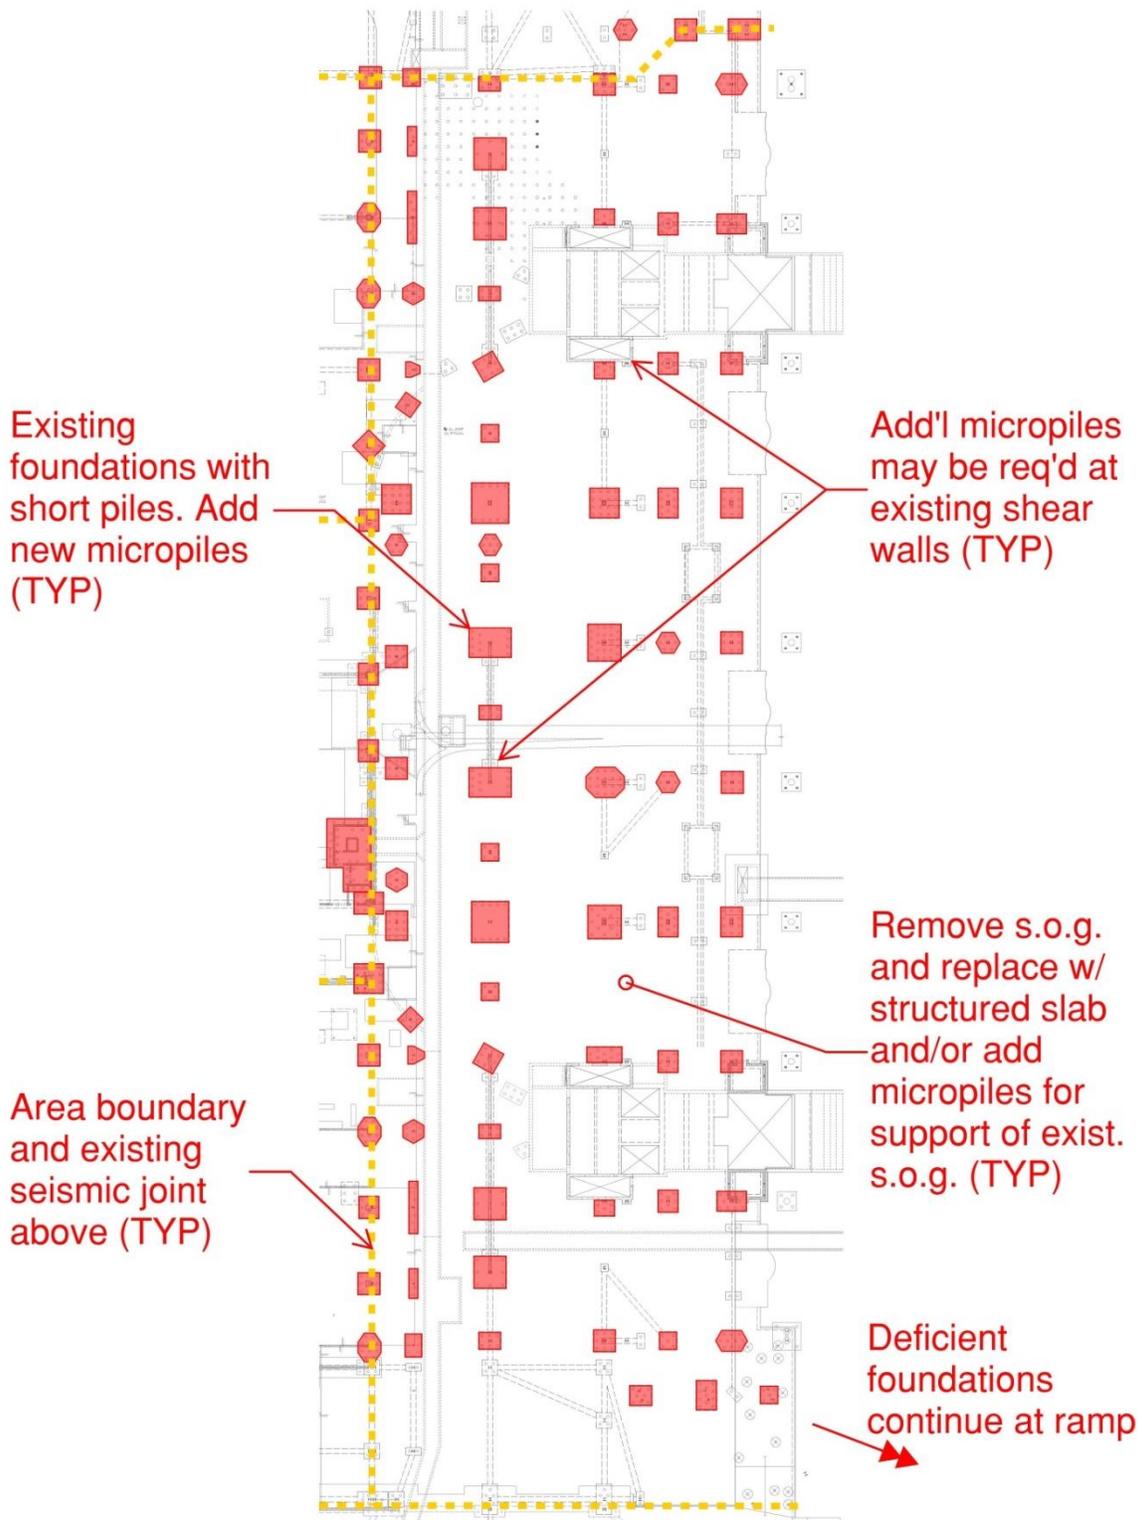
Figure 10a

Terminal Area T1 - Mitigation
(Deplaning)

Mitigation: Mitigation will necessarily address both the liquefaction issues along with the seismic strength and ductility of the lateral force resisting system (LFRS). Potential mitigation schemes are identified below. Refer to Figure 10a, 10b and 10c for proposed concept mitigation scheme.

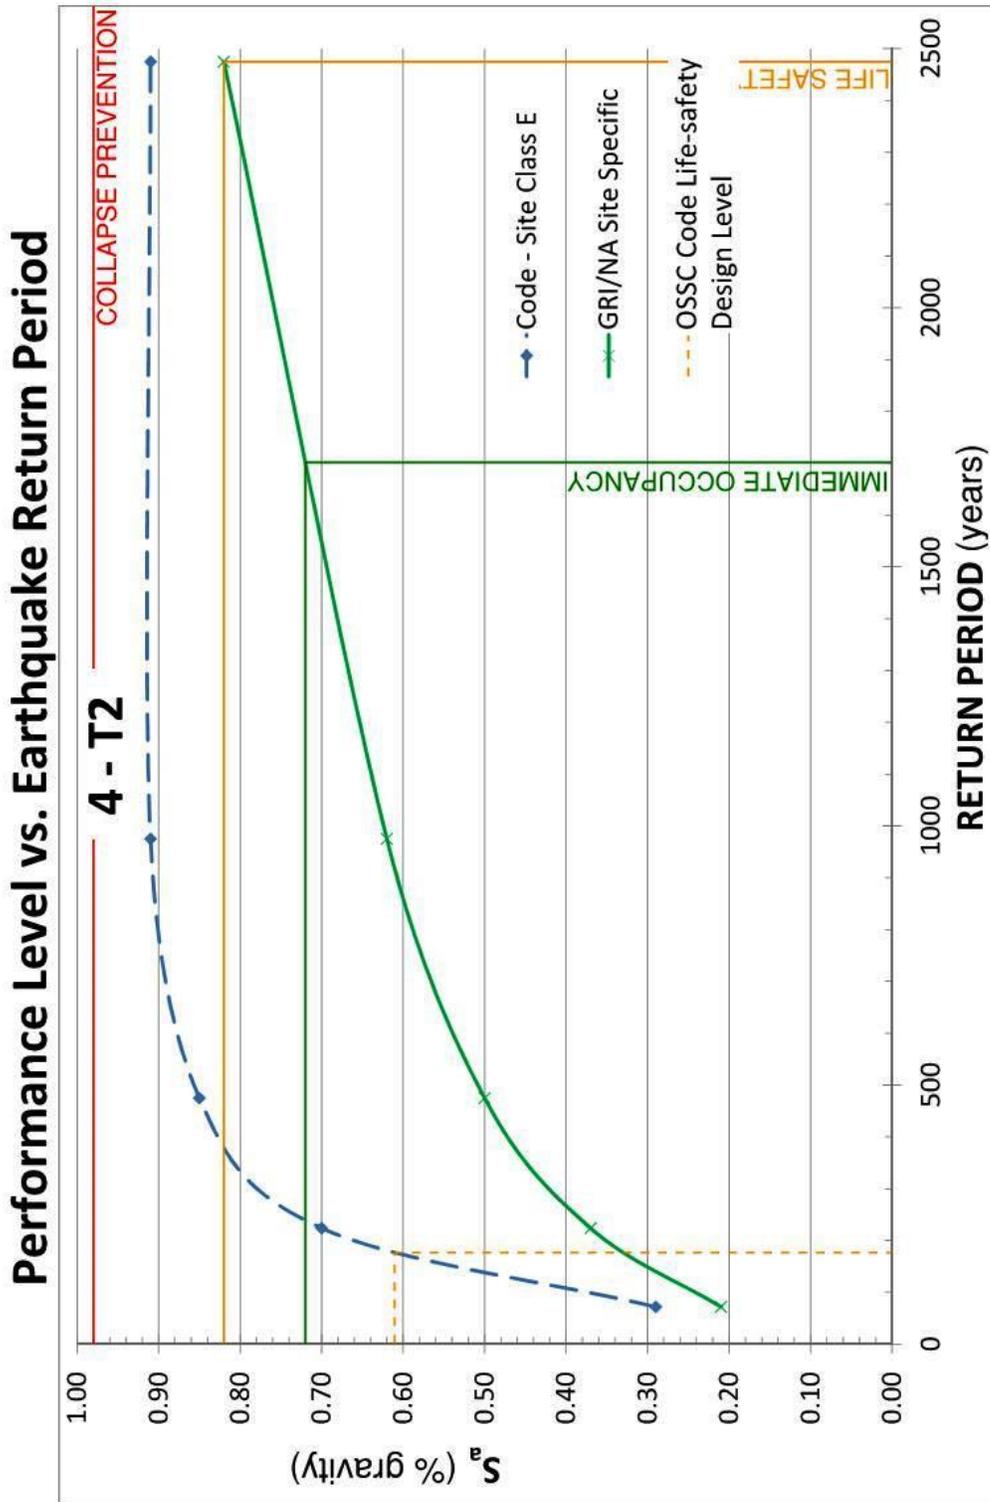
Figure 11

The evaluation of the existing structure using ASCE 41 performance criteria and site specific response spectra developed for this study, results in the following estimates of return period earthquake for the three performance levels considered (without consideration of liquefaction effects) as shown in Figure 11:

Note: Performance does not include the effects of liquefaction.

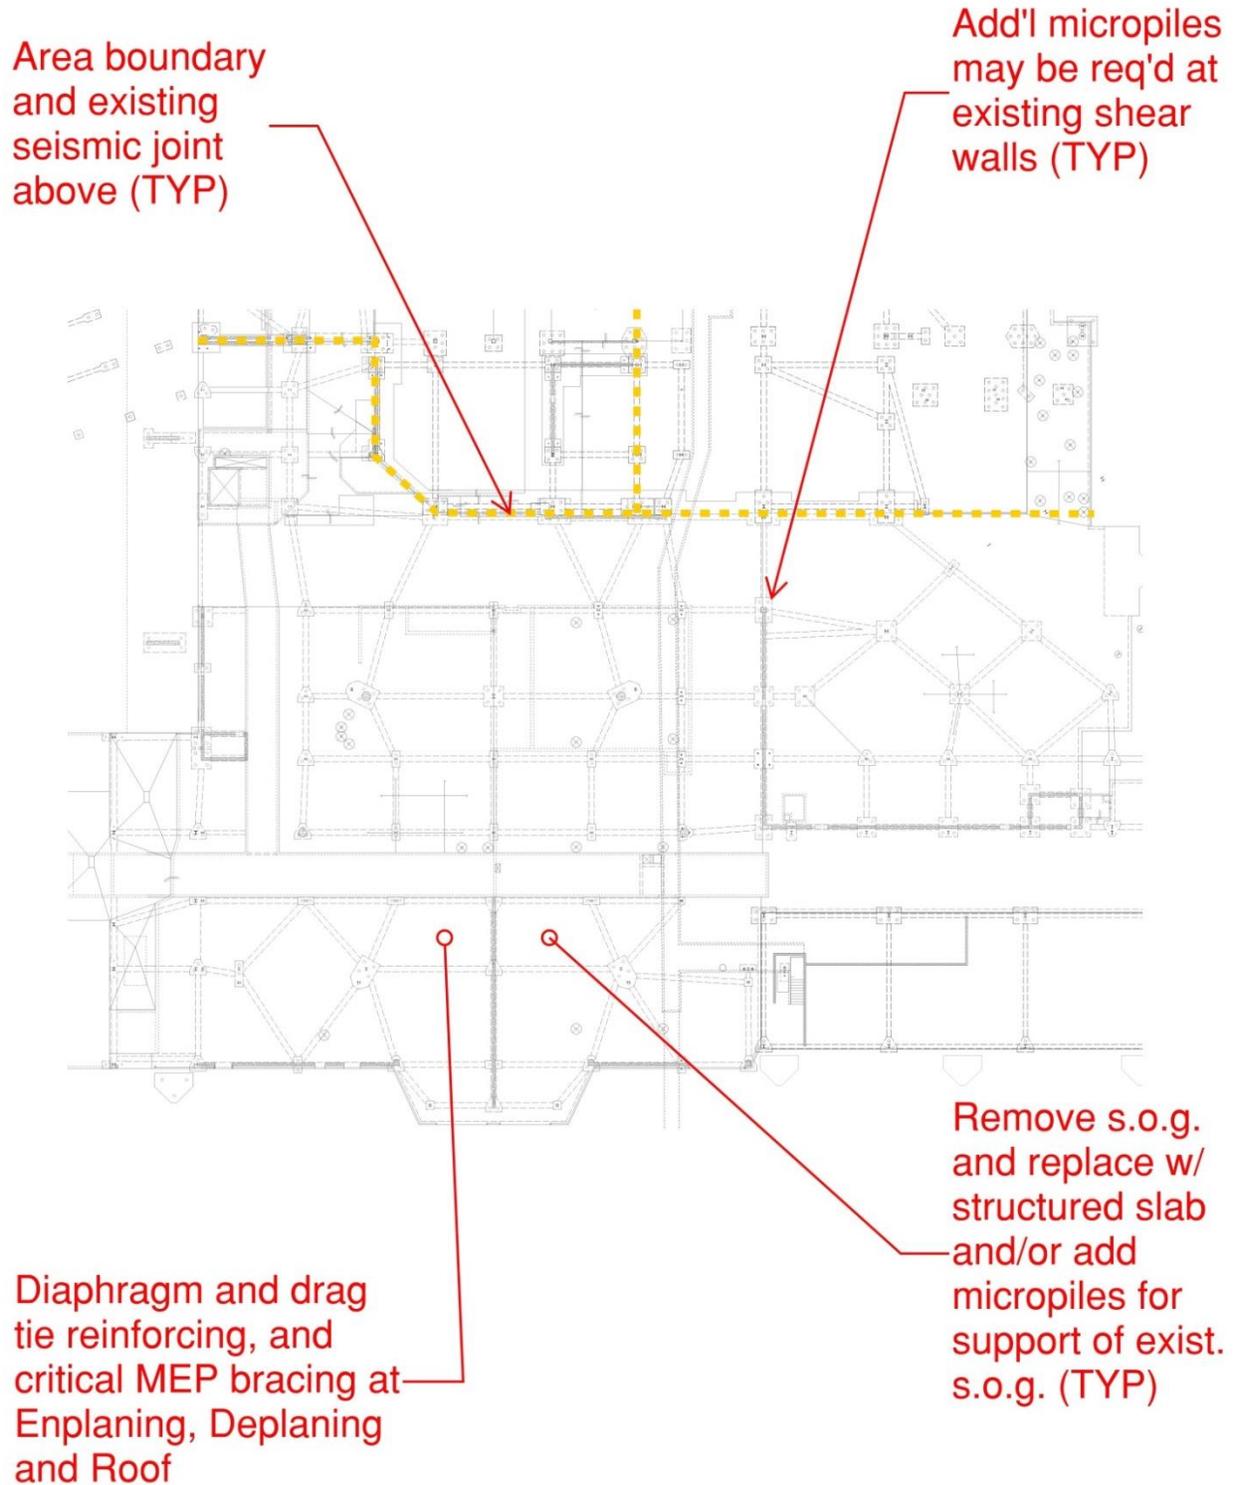
Terminal Area T2 - Mitigation
(Deplaning)

Mitigation: Mitigation will necessarily address both the liquefaction issues of the slab-on-grade along with ductility of the lateral force resisting system (LFRS). Potential mitigation schemes are identified below. Refer to Figure 12 for proposed concept mitigation scheme.

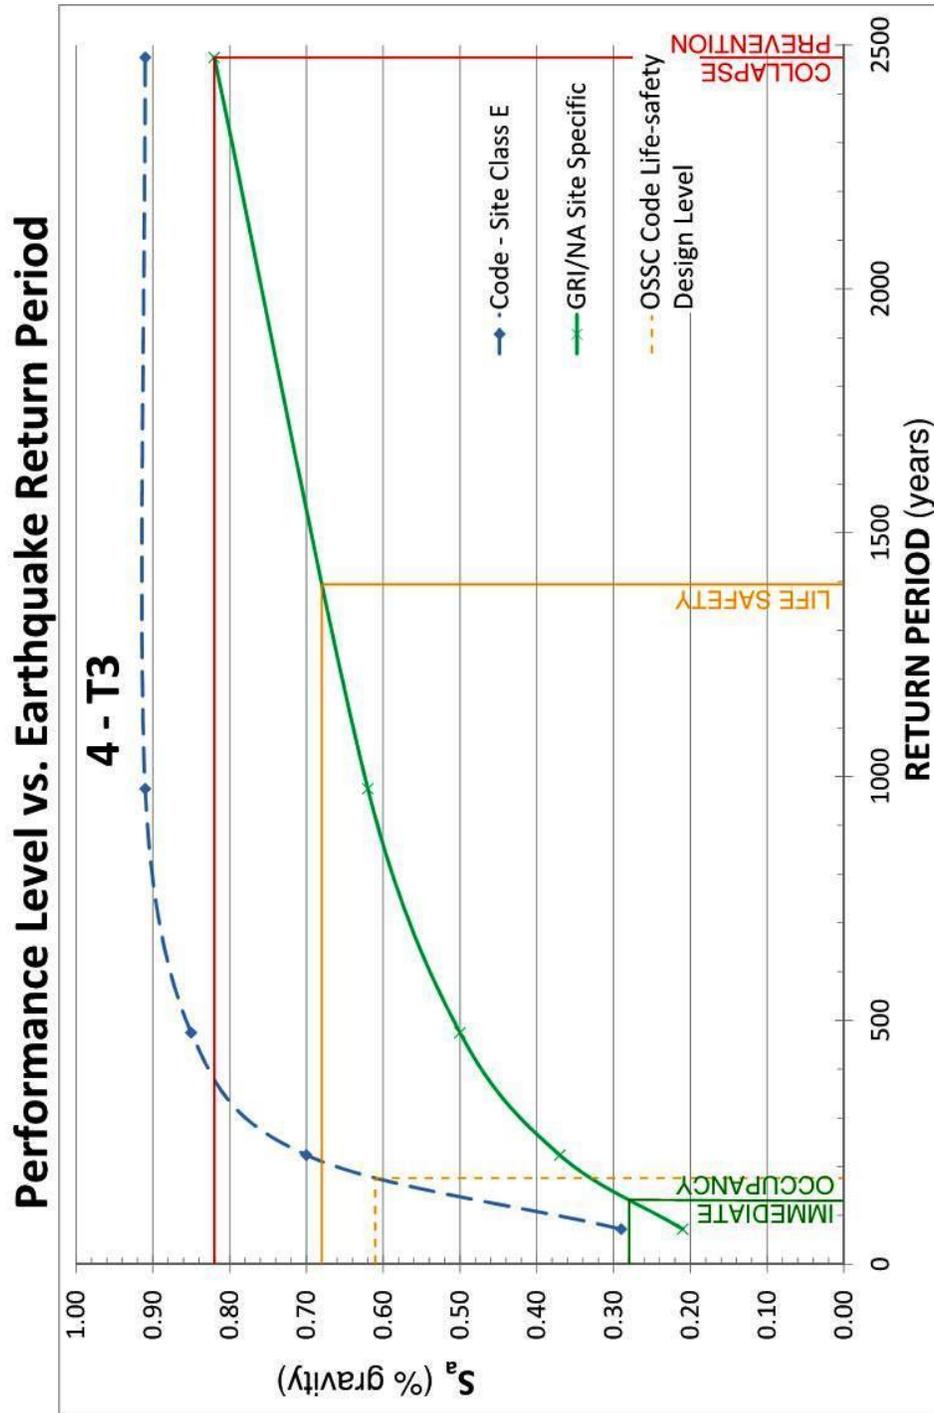
Figure 13

The evaluation of the existing structure using ASCE 41 performance criteria and site specific response spectra developed for this study, results in the following estimates of return period earthquake for the three performance levels considered (without consideration of liquefaction effects) as shown in Figure 13:

Note: Performance does not include the effects of liquefaction.

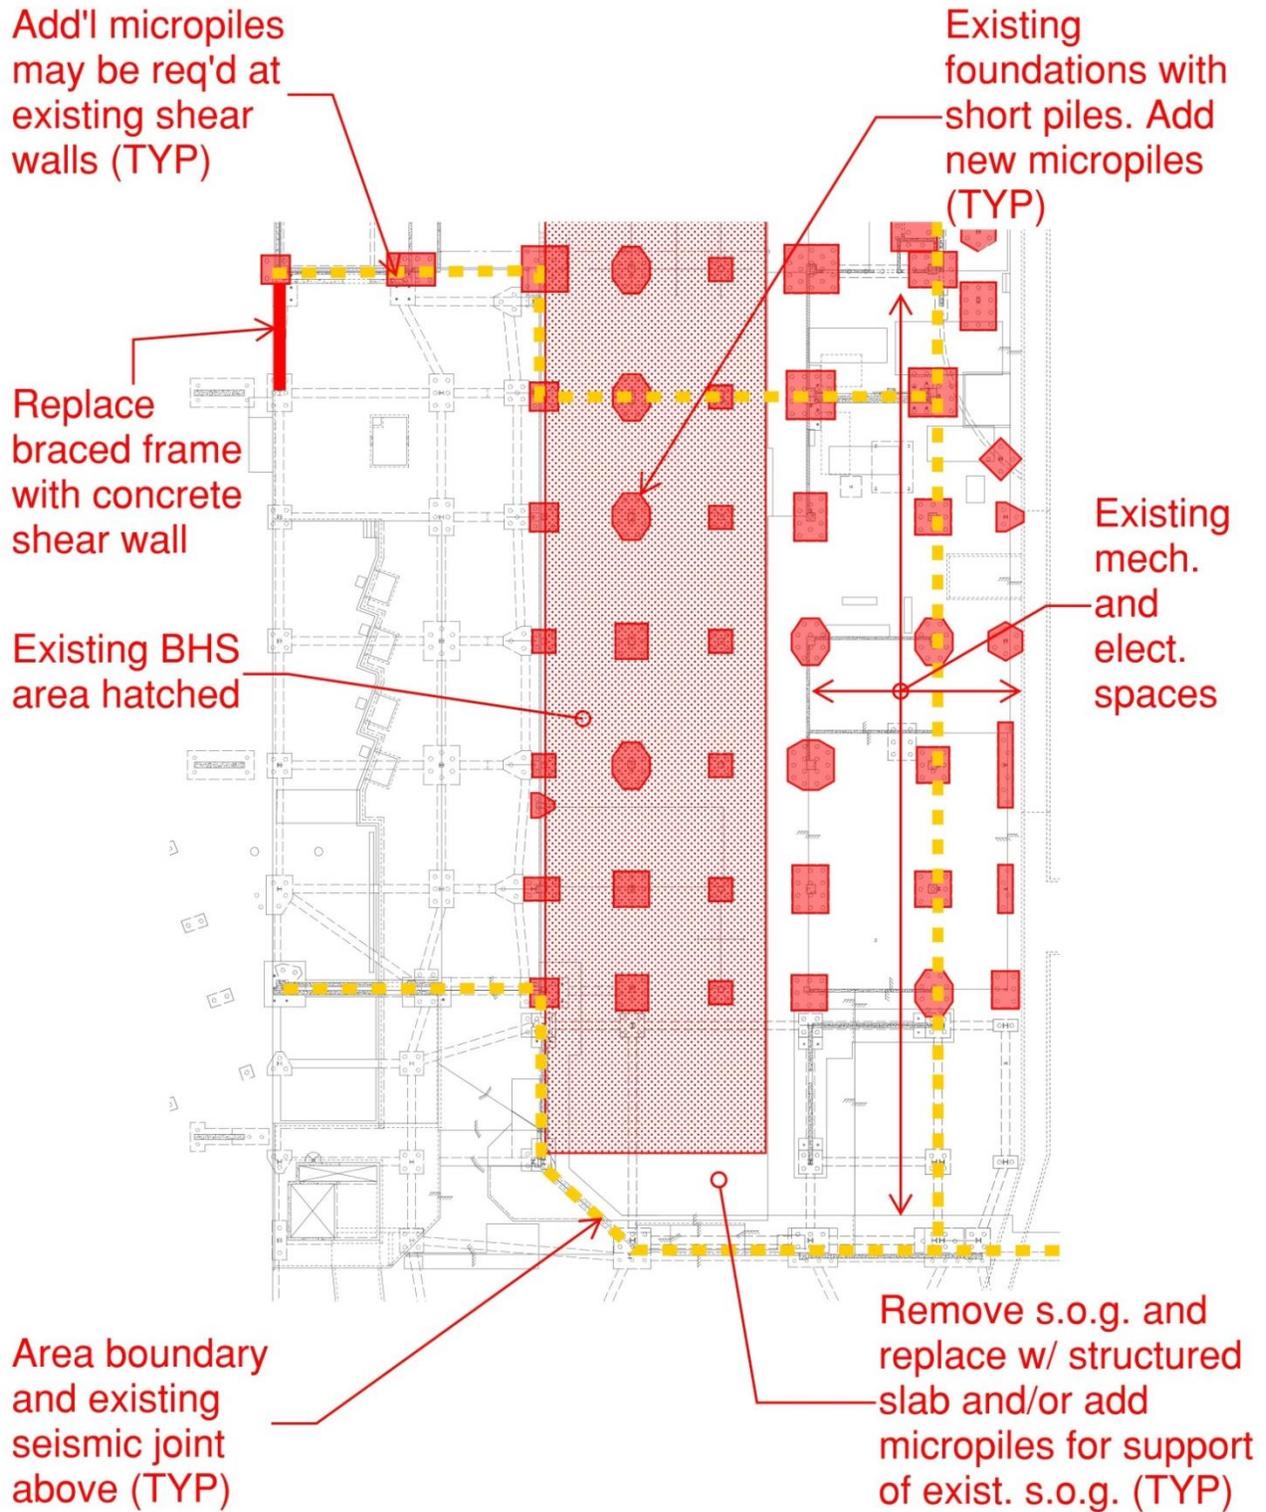
Figure 14a

Terminal Area T3 - Mitigation

Mitigation: Mitigation will necessarily address both the liquefaction issues along with the seismic strength and ductility of the lateral force resisting system (LFRS). Potential mitigation schemes are identified below. Refer to Figure 14a, 14b and 14c for proposed concept mitigation scheme.

Replace
brace
with BRB

Replace
braced frame
with concrete
shear wall

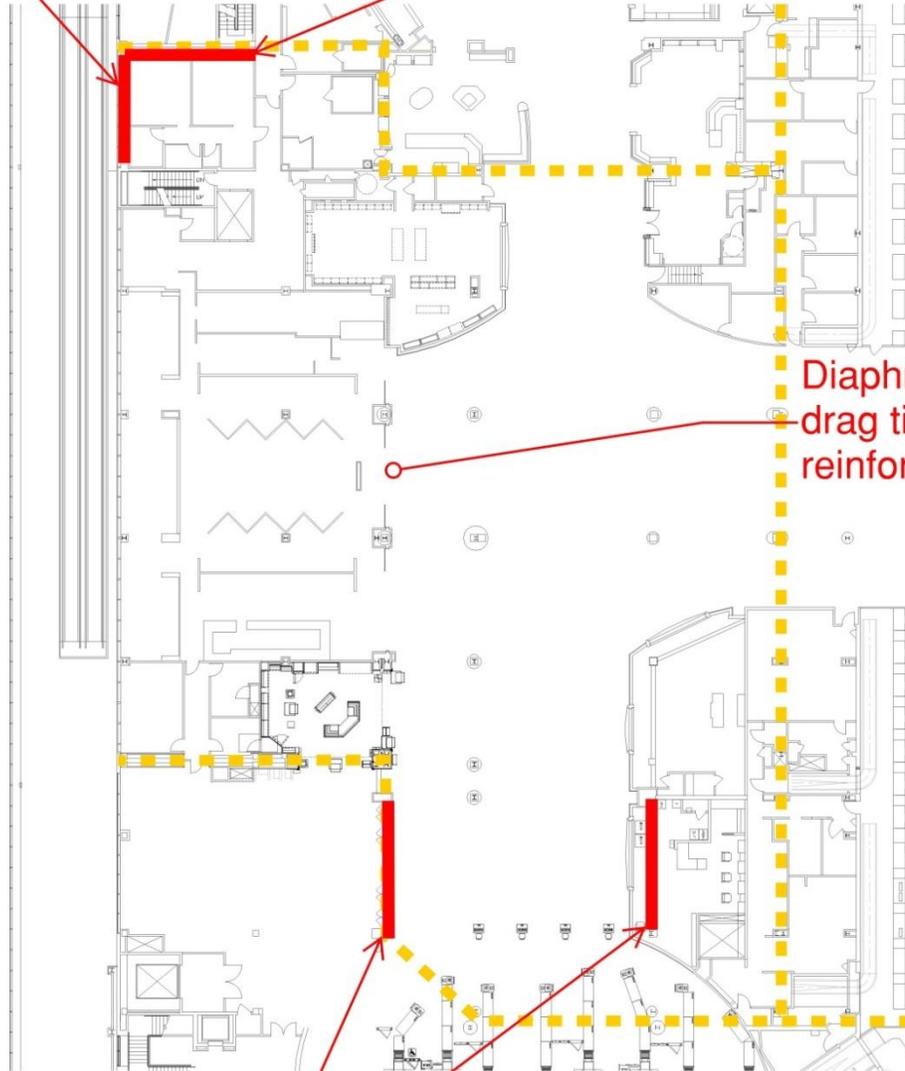
Figure 14b

Terminal Area T3 - Mitigation (Enplaning)

Diaphragm and
drag tie
reinforcing

Add column in
inverted-V
bracing. Replace
braces w/ BRBs

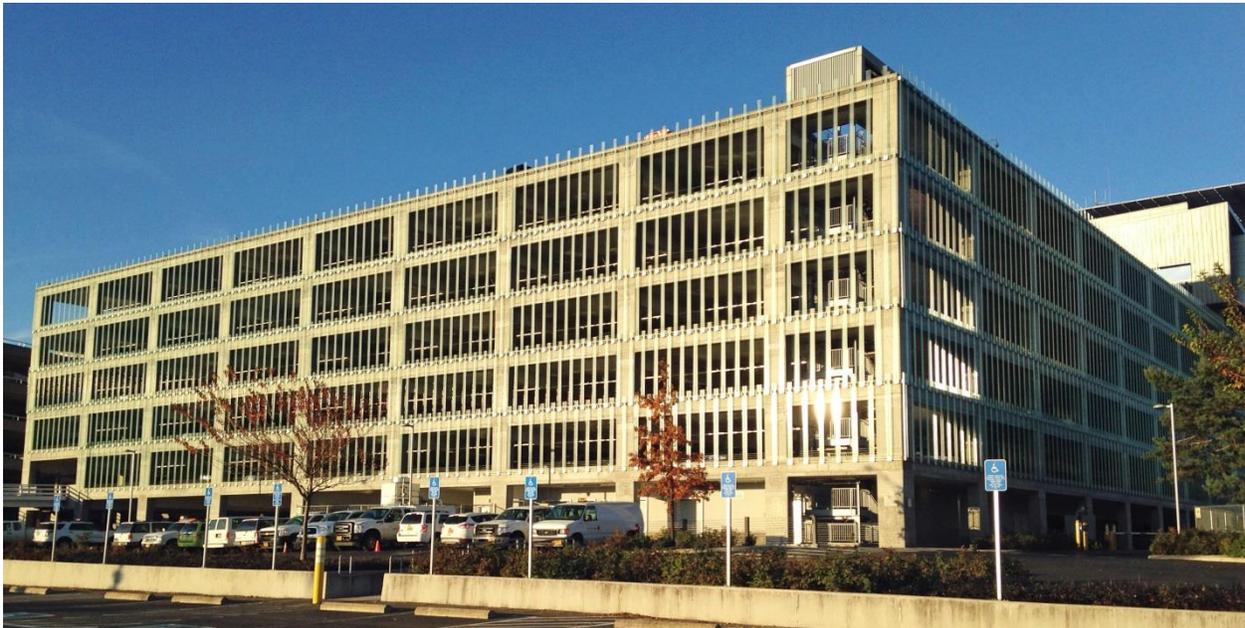
Building ID#: 6b

Building Description: The south half of the P2 parking garage has seven levels of parking.

Building Structural System: The gravity system for the parking levels consists of post-tensioned concrete beams and floor slabs. The lateral system in the N-S direction is a dual-system, special concrete shear walls with special concrete moment resisting frames, and special moment resisting frames in the E-W direction. The ground floor is slab-on-grade. The foundations are supported on steel piles. The building was designed to accommodate three levels of office space similar to P2 North.

General Seismic Performance: P2 South meets the current Code design and detailing requirements for standard parking in Seismic Design Category D. Without the office addition, the existing P2 structure exceeds the Code seismic design force requirement for performance expectations of collapse prevention under a 2475-year return period earthquake, and life-safety under an earthquake with accelerations of 2/3 that of the 2475-year event. The site is susceptible to liquefaction during a seismic event, which may cause localized settlement in the slab-on-grade. Magnitudes of settlement are expected to exceed a foot with a 1000-year, or greater, return period event. The utility tunnel from the Central Utility Plant runs under P2 South, and connects with the pedestrian tunnel. This will cause disruption of functions and services that rely on the
