Port of Portland Corporate Seismic Risk Assessment Study

Final Report

May 2015

Port of Portland

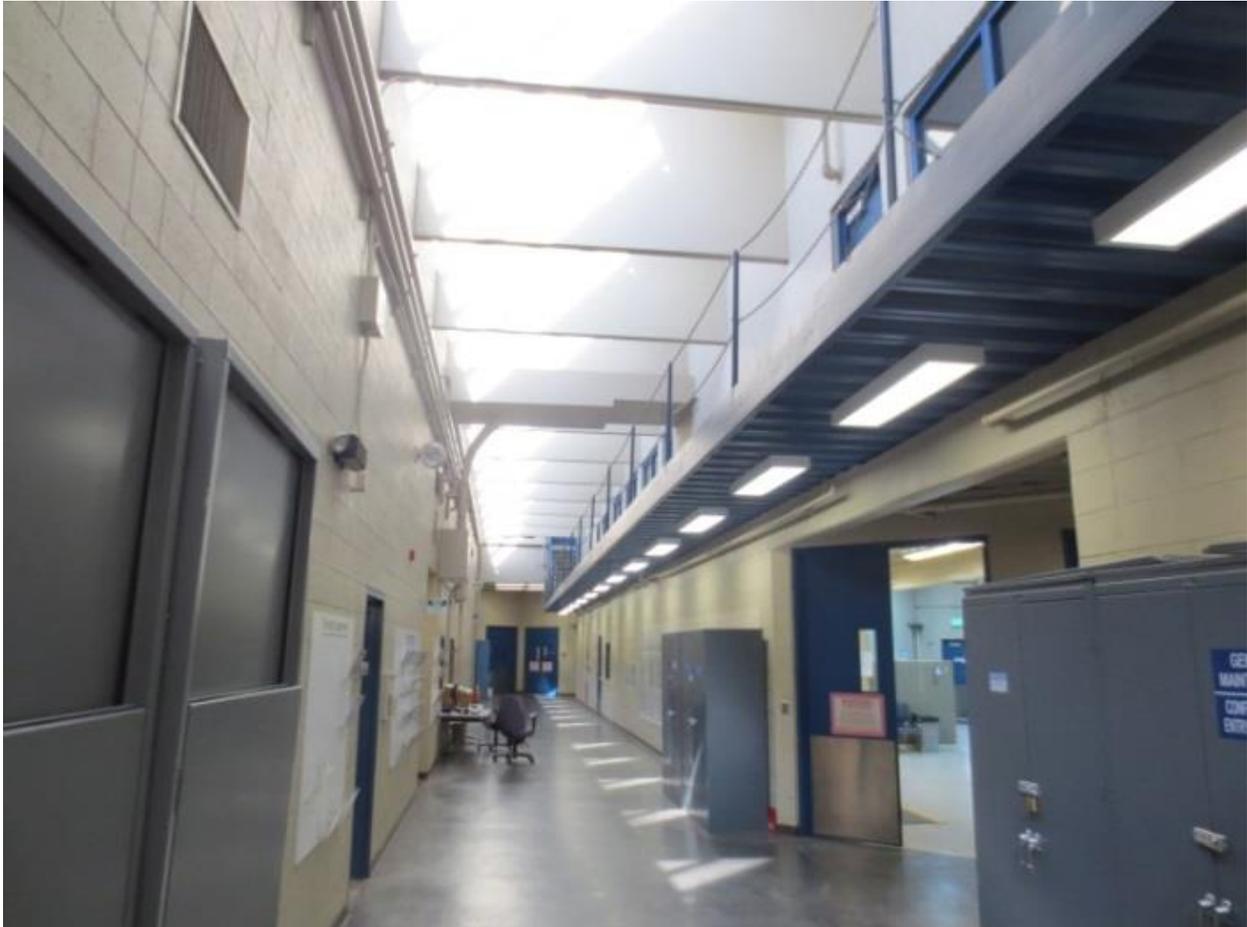
Building ID#: 13

Building Description: Building B is a one-story structure comprised of office, storage and maintenance spaces, with a small second story section with a balcony and two interior mezzanines. The south side of the building has a large soil berm against the building face up to mid-height of the structure.

Building Structural System: Precast, hollow-core, concrete panels perform as exterior bearing/shear walls, supporting a majority of both the gravity and lateral loads of the structure. The precast panels along the south building face are supported by a cast-in-place concrete retaining wall, due to the soil berm. Interior steel framing supports roof members, as well as the two mezzanines. The roof structure is comprised of either wood framing with plywood diaphragms spanning up to 140 feet, or open web three-dimensional “Unistrut” trusses with steel roof decking.

General Seismic Performance: The Ground Maintenance Administration and Shops was constructed prior to the significant increases in seismic design loads that occurred in the 1990’s, and has a lateral system that has been penalized by Code due to a lack of ductility. The roof diaphragm is lacking continuous cross-ties and the ledger is loaded in cross-grain bending which are common failure mechanisms in buildings of this type and era. Additionally, the roof levels in Buildings B and C are offset, which can cause significant damage to the structure in that area. One of the interior mezzanines has steel concentric braced frames; but the other appears to be unbraced. The site is susceptible to liquefaction, which may cause ground settlements of 1½ feet under earthquakes with a return period as short as 200 years. Spread footings may see an additional foot of settlement. Settlements of this magnitude, along with the other seismic deficiencies, are expected to result in a building that is unusable after an approximately 200-year return period, or greater, earthquake.

Next Steps: Mitigation would need to address both the seismic deficiencies as well as the liquefaction issues. It is quite likely that the cost of such mitigation will make replacement of the facility a preferable option; particularly when viewed with the superior performance (structurally, functionally, and energy efficiency) of a new building. A detailed geotechnical investigation could yield more accurate liquefaction predictions; however, it is unlikely that the effects would be found to be negligible.

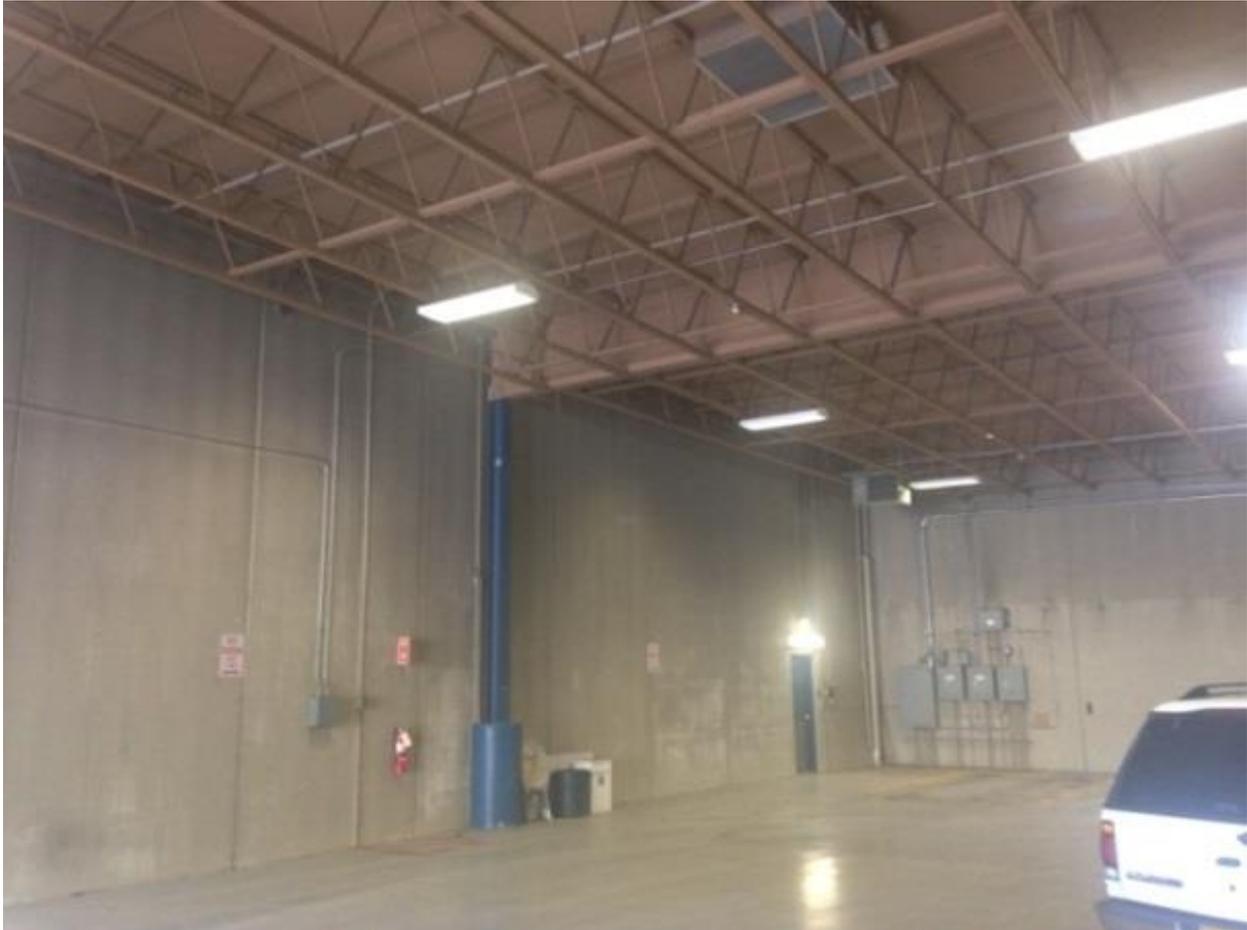
Building Name: Ground Maintenance Facility (Building A)

Building Description: Building A is a large one-story vehicle parking and storage warehouse. The east side of the building has a large soil berm against the building face up to mid-height of the structure.

Building Structural System: Precast, hollow-core, concrete panels perform as exterior bearing/shear walls, with interior steel columns supporting glulam beams and open-web, steel joists at the roof level. The roof diaphragm is plywood sheathing, spanning 180 feet between shear walls. The precast panels along the east building face are supported by a cast-in-place concrete retaining wall that resists the pressure of the soil berm. The ground floor is slab-on-grade. The foundations are spread footings.

General Seismic Performance: The Ground Maintenance Facility was constructed prior to the significant increases in seismic design loads that occurred in the 1990’s, and has a lateral system that has been penalized by Code due to a lack of ductility. The roof diaphragm is lacking continuous cross-ties and the ledger is loaded in cross-grain bending which are common failure mechanisms in buildings of this type and era. The site is susceptible to liquefaction, which may cause ground settlements of 1½ feet under earthquakes with a return period as short as 200 years. Spread footings may see an additional foot of settlement. Settlements of this magnitude, along with the other seismic deficiencies, are expected to result in a building that is unusable after an approximately 200-year return period, or greater, earthquake.

Next Steps: Mitigation would need to address both the seismic deficiencies as well as the liquefaction issues. It is quite likely that the cost of such mitigation will make replacement of the facility a preferable option; particularly when viewed with the superior performance (structurally, functionally, and energy efficiency) of a new building. A detailed geotechnical investigation could yield more accurate liquefaction predictions; however, it is unlikely that the effects would be found to be negligible.

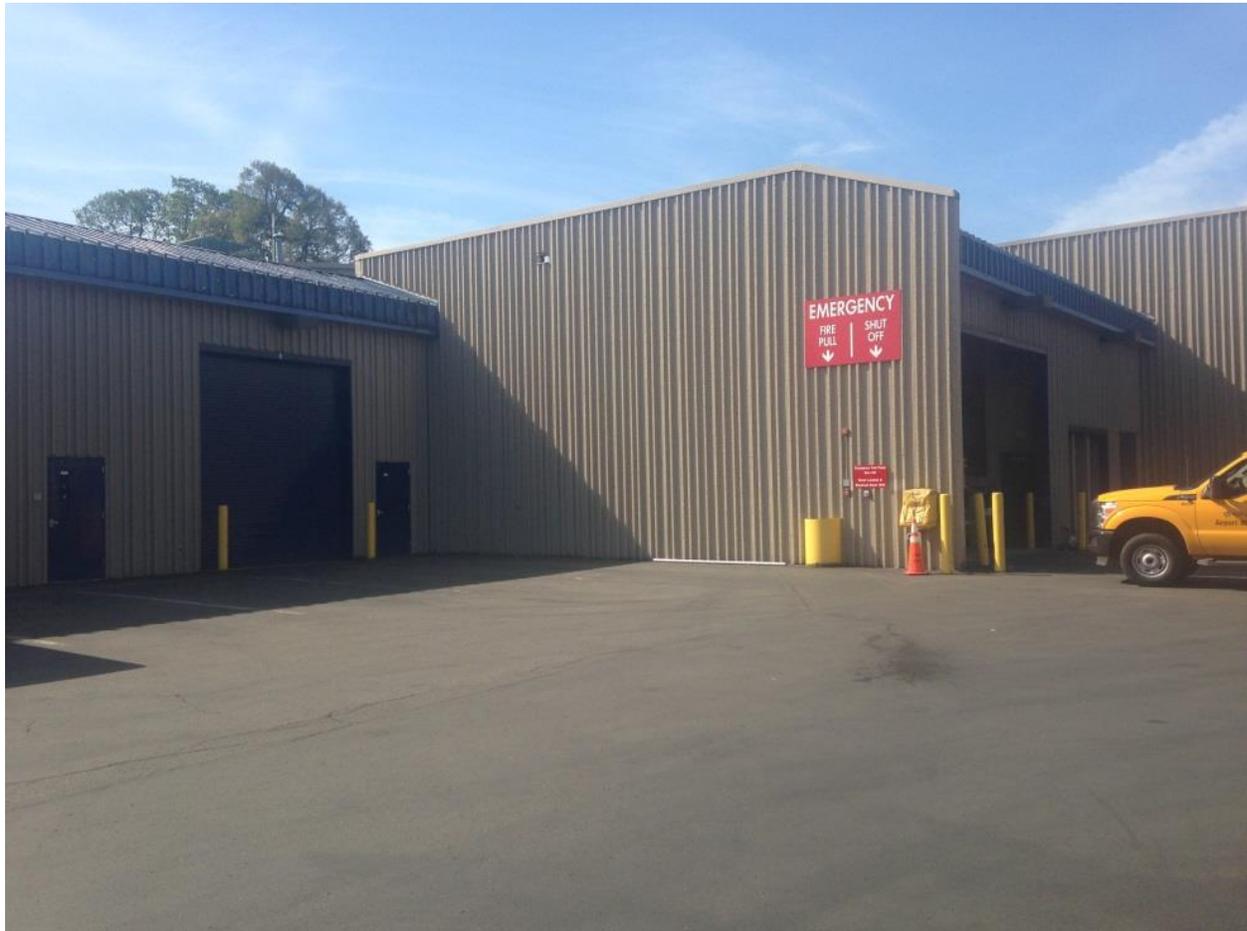
Building ID#: 15

Building Description: Building C is a one-story vehicle maintenance and supply storage warehouse with a small interior mezzanine.

Building Structural System: Precast, hollow-core, concrete panels perform as exterior bearing/shear walls, with interior steel columns supporting glulam beams and solid wood joists at the roof level. The roof diaphragm is plywood sheathing, spanning up to 140 feet between shear walls. The mezzanine has CMU walls with a reinforced concrete floor slab. The ground floor is slab-on-grade. The foundations are spread footings.

General Seismic Performance: The Ground Maintenance Facility was constructed prior to the significant increases in seismic design loads that occurred in the 1990’s, and has a lateral system that has been penalized by Code due to a lack of ductility. The roof diaphragm is lacking continuous cross-ties and the ledger is loaded in cross-grain bending which are common failure mechanisms in buildings of this type and era. Additionally, the roof levels in Buildings B and C are offset – 18 feet vs. 27 feet, which can cause significant damage to the structure in that area. The site is susceptible to liquefaction, which may cause ground settlements of 1½ feet under earthquakes with a return period as short as 200 years. Spread footings may see an additional foot of settlement. Settlements of this magnitude, along with the other seismic deficiencies, are expected to result in a building that is unusable after an approximately 200-year return period, or greater, earthquake.

Next Steps: Mitigation would need to address both the seismic deficiencies as well as the liquefaction issues. It is quite likely that the cost of such mitigation will make replacement of the facility a preferable option; particularly when viewed with the superior performance (structurally, functionally, and energy efficiency) of a new building. A detailed geotechnical investigation could yield more accurate liquefaction predictions; however, it is unlikely that the effects would be found to be negligible.

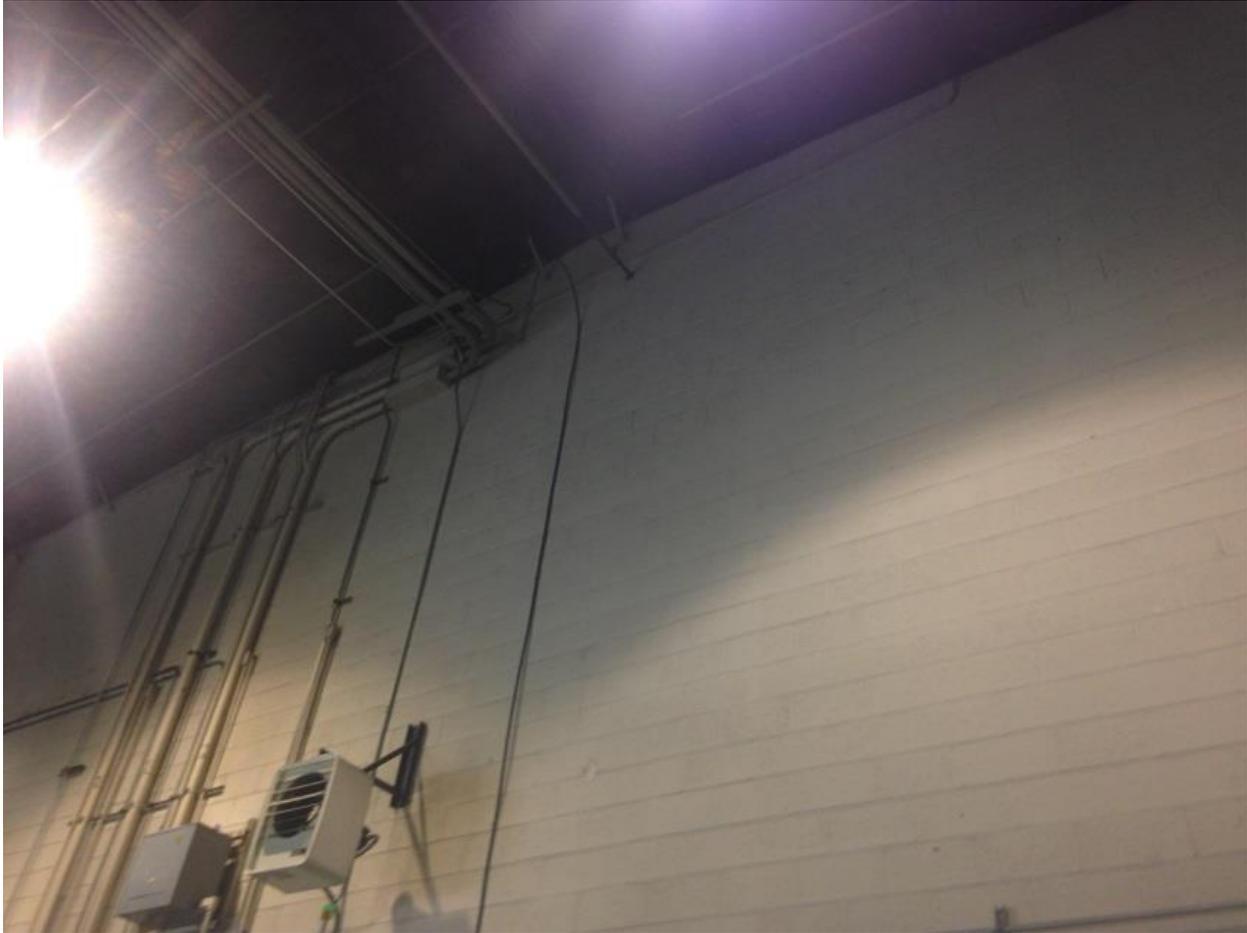
Building ID#: 16

Building Description: The Maintenance Warehouse is a Butler-type, pre-fabricated steel building. It consists of a one-story warehouse/shop space with two mezzanines, as well as a two-story office space.

Building Structural System: The building consists of steel framing with precast concrete wall panels bolted to the frames extending to mid-height of the structure. The roof is framed with z-girts and metal roof deck. The upper side walls are framed with Z-girts and metal panels. There are two interior mezzanines with reinforced masonry walls, as well as a two-story infill portion consisting of full height reinforced masonry walls up to the roof level. The framing of the mezzanines and 2nd story are open web steel joists supporting concrete topping over metal decking. The lateral system is comprised of two bays of tension-only steel rod bracing occurring along each exterior building wall, from the top of the precast panels to the roof diaphragm,

along with moment frames in the east-west direction. The ground floor is slab-on-grade. Foundations are spread footings.

Next Steps: Mitigation would need to address both the seismic deficiencies as well as the liquefaction issues. A more detailed geotechnical, structural, and MEP investigation could determine what mitigation strategies, if any, might be practical and economical for a building of this type and considering its remaining useful service life.

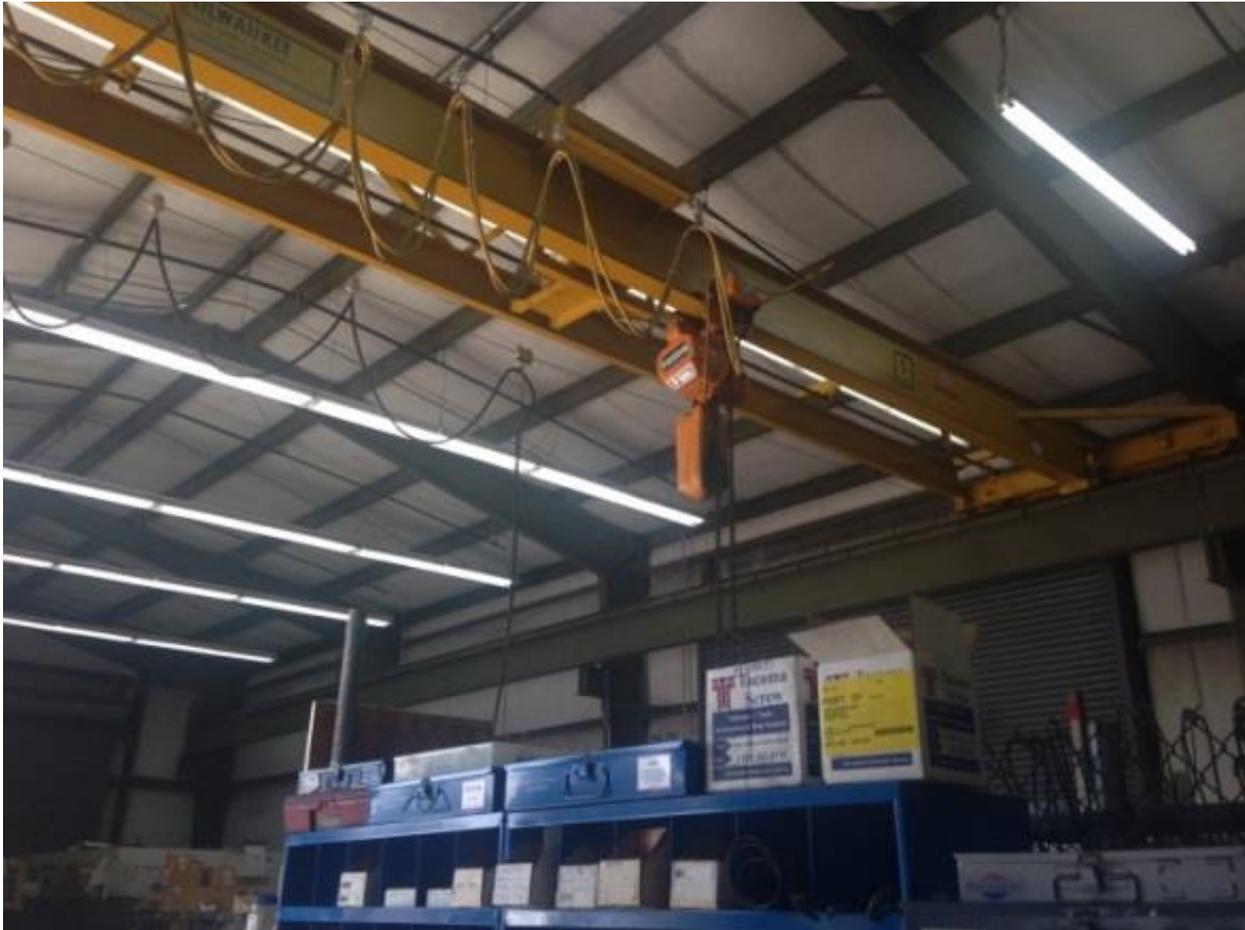
Building ID#: 17

Building Description: The Electrical Shop is a Butler-type, pre-fabricated building. It consists of a one story warehouse/shop space with a mezzanine, as well as a two-story office space.

Building Structural System: The Shop is a steel framed building with roof and wall framing consisting of steel Z-girts and metal panels. Ground floor is slab-on-grade. Foundations are spread footings. The lateral system is comprised of steel moment frames in the east-west direction and two observable bays of tension-only cable bracing on each side of the structure in the north-south direction.

There were a number of storage cabinets and parts racks that were not seismically braced which pose a hazard during a seismic event.

Next Steps: Mitigation would need to address both the seismic deficiencies as well as the liquefaction issues. A more detailed geotechnical, structural, and MEP investigation could determine what mitigation strategies, if any, might be practical and economical for a building of this type and considering its remaining useful service life.

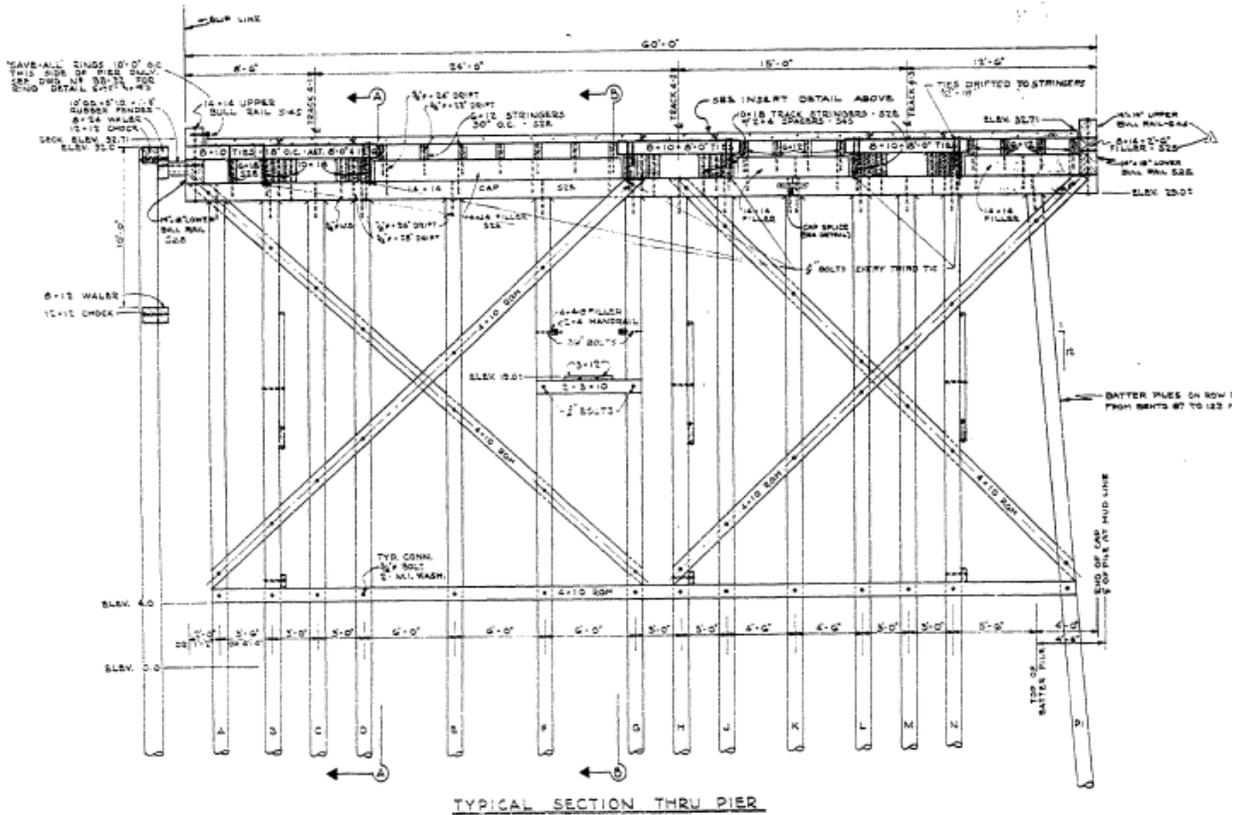
Figure 1 – Berth 410 typical pier section

The overall condition of the pier appeared to be fair with some of structural members exhibiting deterioration and water staining, including the diagonal bracing and pile caps. Lower brace to pile connections were deteriorated in many locations. Water intrusion from the deck appears significant.

Live loads have been restricted by the Port due to the condition of the structure. The primary uses of the pier appear to be as an access path to the mooring dolphin at the outboard end of the pier and as a berthing platform.

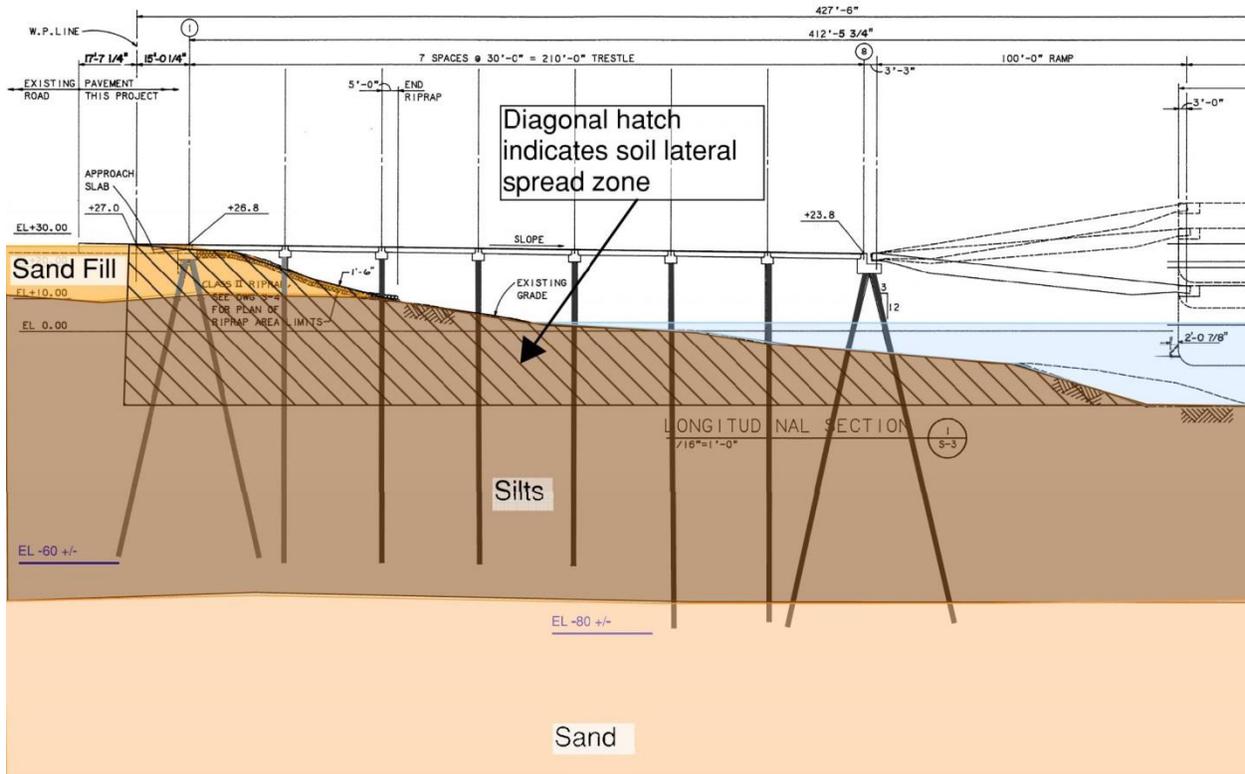
Figure 11 – Berth 601 trestle longitudinal section indicating zone of soil lateral spreading

Soil lateral spreading displacements are expected to be significant at Berth 601. Figure 11 below shows a longitudinal section at Berth 601 approach trestle indicating the potential zone of soil lateral spreading.

Soil lateral spread displacements were estimated at 4 feet at the OLE and 17 feet for the CLE. Due to these expected displacements, the trestle and mooring dolphins may be significantly damaged at the OLE.
