**Subject: Cultural Resources Risk Assessment for the Terminal 2 Mass Timber EDA Project, Portland, Oregon**

Port of Portland, Mass Timber EDA Grant

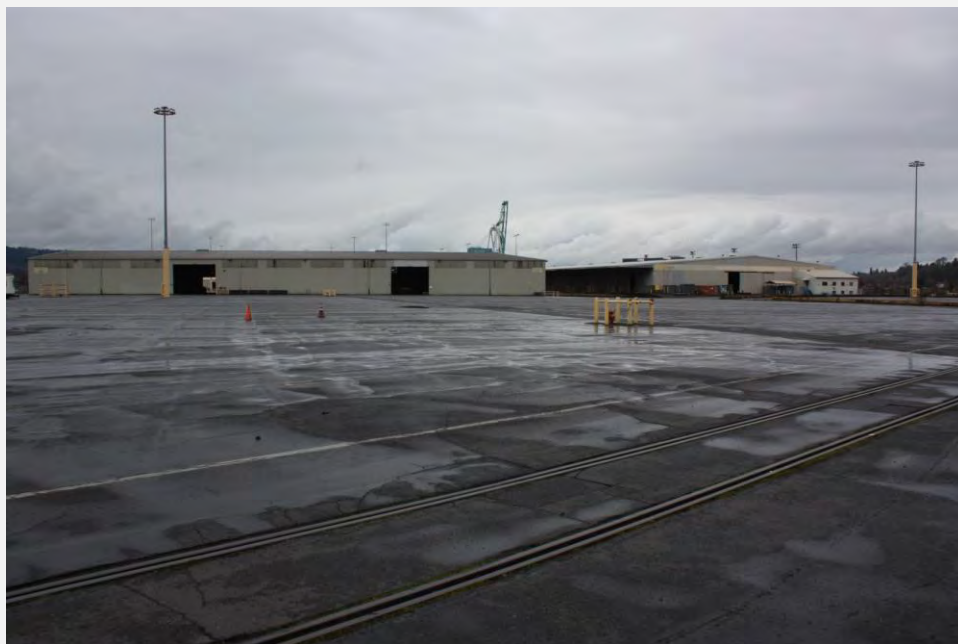
**Exhibit 9.** Looking north towards Warehouses 205 and 206.

Terminal 2 is situated between Highway 30 and the Willamette River on a flat landform, which is entirely paved (Exhibit 9). Terminal 2, itself, remains to be used for industrial activities and is considered to be part of the historic built environment. The developed property includes parking lots, rail lines for loading and unloading goods. No landscaping or unpaved areas exist within the APE, thereby making preconstruction subsurface testing impossible. No archaeological objects, artifacts, or features were observed adjacent or within Warehouse 205 (built in 1971), which is the only historic building remaining within Terminal 2. Nor were any archaeological materials observed elsewhere within Terminal 2.

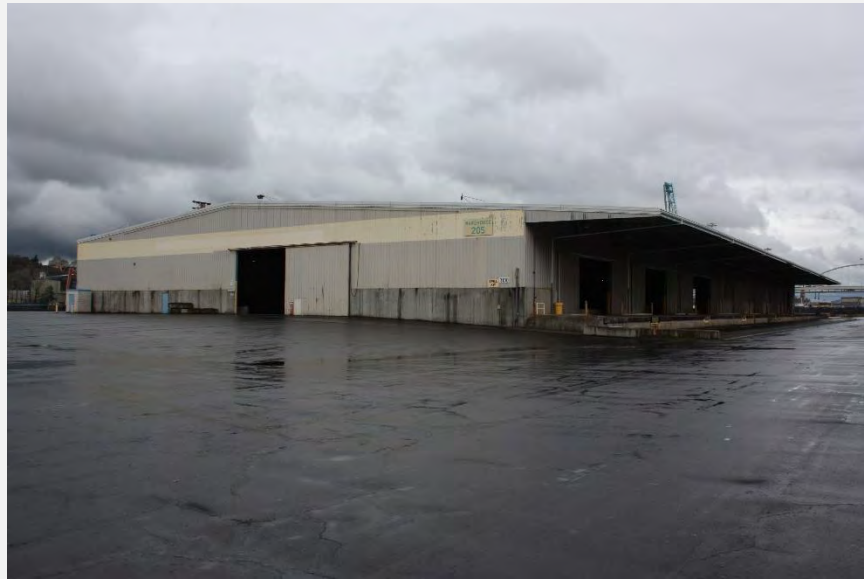
**Exhibit 11.** Warehouse 205, looking east at the northwest elevation.

Several buildings are located within in the legal parcels of Terminal 2. A single warehouse, Warehouse 205, appears to be the only extant building from the historic period. The building, an unused warehouse, is rectangular and measures approximately 460 feet by 235 feet. The building sits on a concrete foundation wall and upper section of the building is clad in corrugated metal (Exhibit 11). The low-pitched roof has a large overhang on the south elevation that covers a concrete loading dock. Large side sliding doors are located on the north and south elevations. A small office and restrooms are located on the northeast corner of the building. Railroad tracks lead from Front Avenue and are located on both the north and south elevations of the building (Exhibit 12).

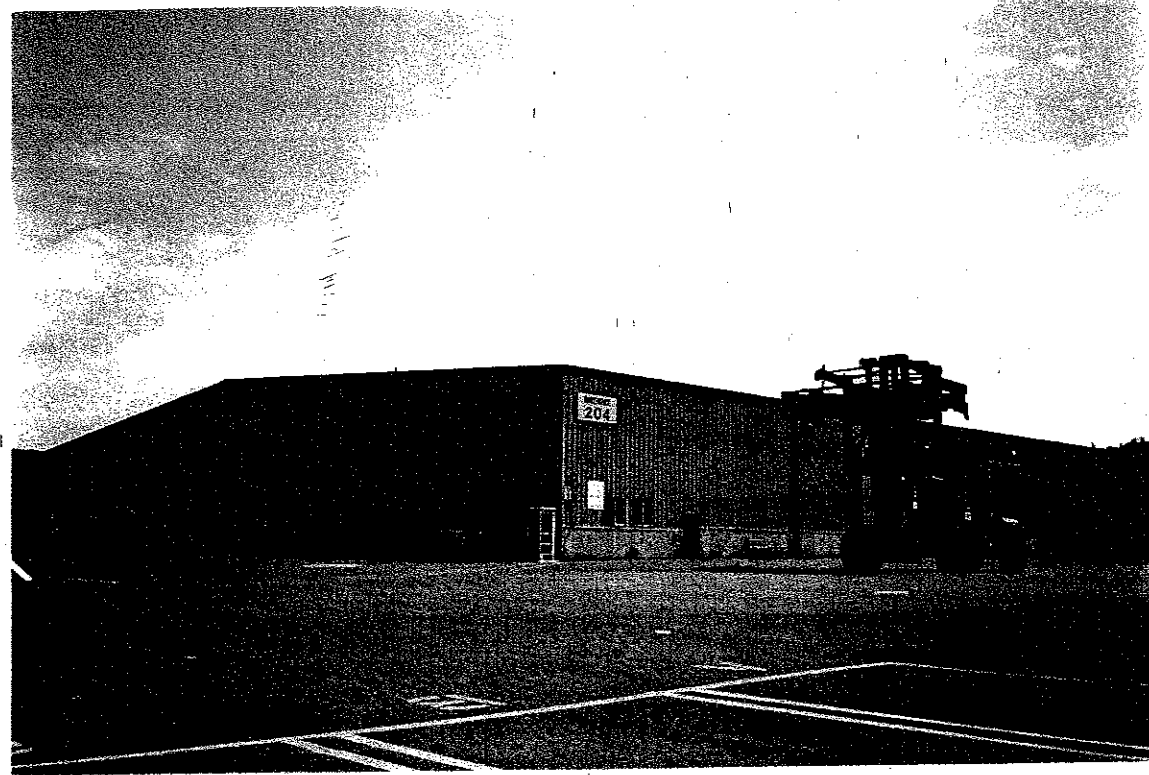
PHOTO 1: WAREHOUSE 204, TERMINAL 2.

No Moderate, High, or Immediate Concern materials were located in this building.

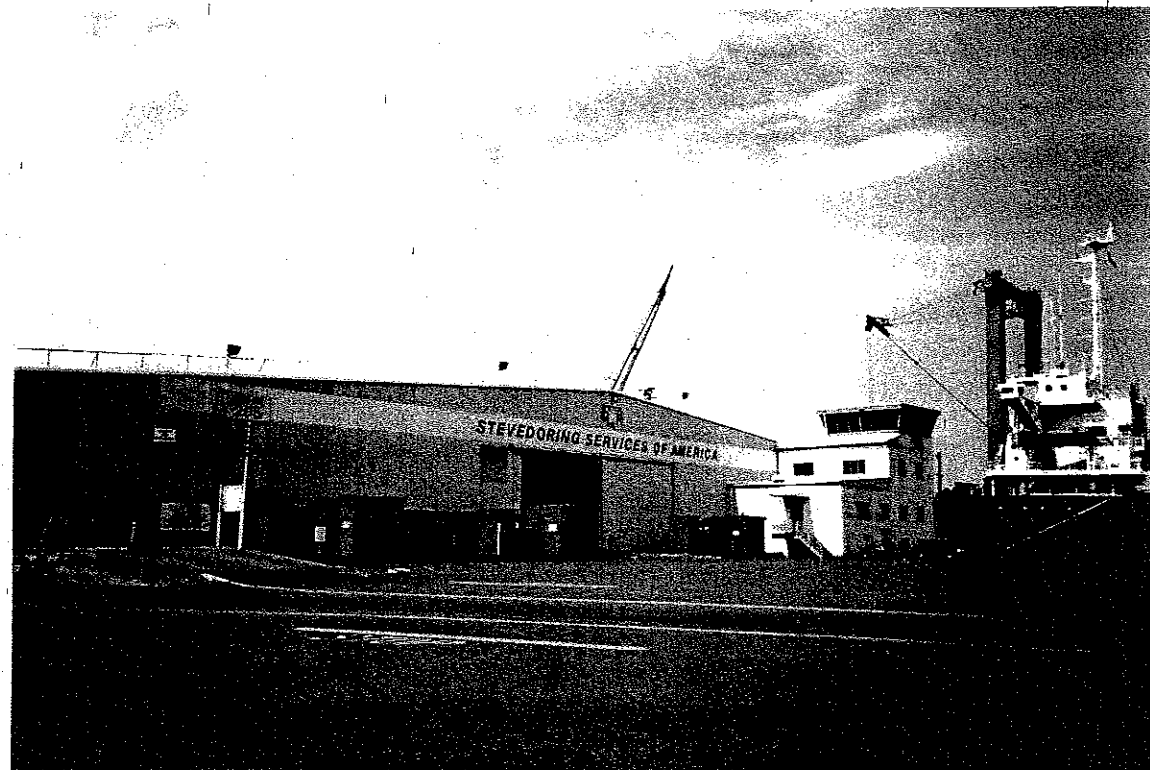
PHOTO 1: WAREHOUSE 205, TERMINAL 2.

APPROXIMATE QUANTITY
1.	MATERIAL Hard Fittings on Fiberglass LOCATION Attic space in basement of office CATEGORY Moderate concern	25 EA
2.	MATERIAL Lay-in Ceiling Tile LOCATION Throughout Warehouse office CATEGORY Moderate concern	1,650 SF
3.	MATERIAL Vinyl Floor Tile/Mastic LOCATION Throughout first floor of office & stairwell CATEGORY Moderate concern	3,130 SF
4.	MATERIAL Stair Coving LOCATION Stairwell of Warehouse 205 office CATEGORY Low concern	50 SF

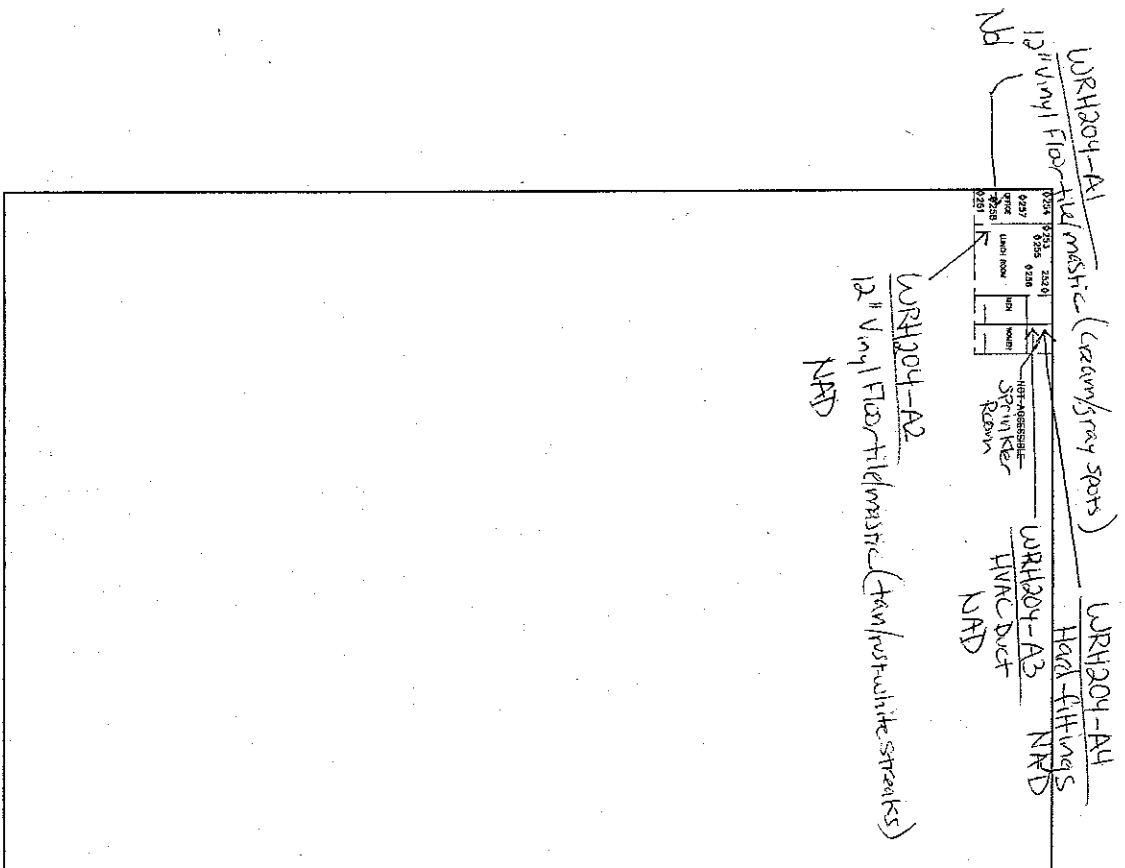
**FLOOR PLAN - WAREHOUSE 204**

No Moderate, High, or Immediate Concern materials were located in this building.

RECOMMENDED COURSE OF ACTION	SUBTOTAL
REMOVE ALL ASBESTOS PRIOR TO DEMOLITION	TOTAL

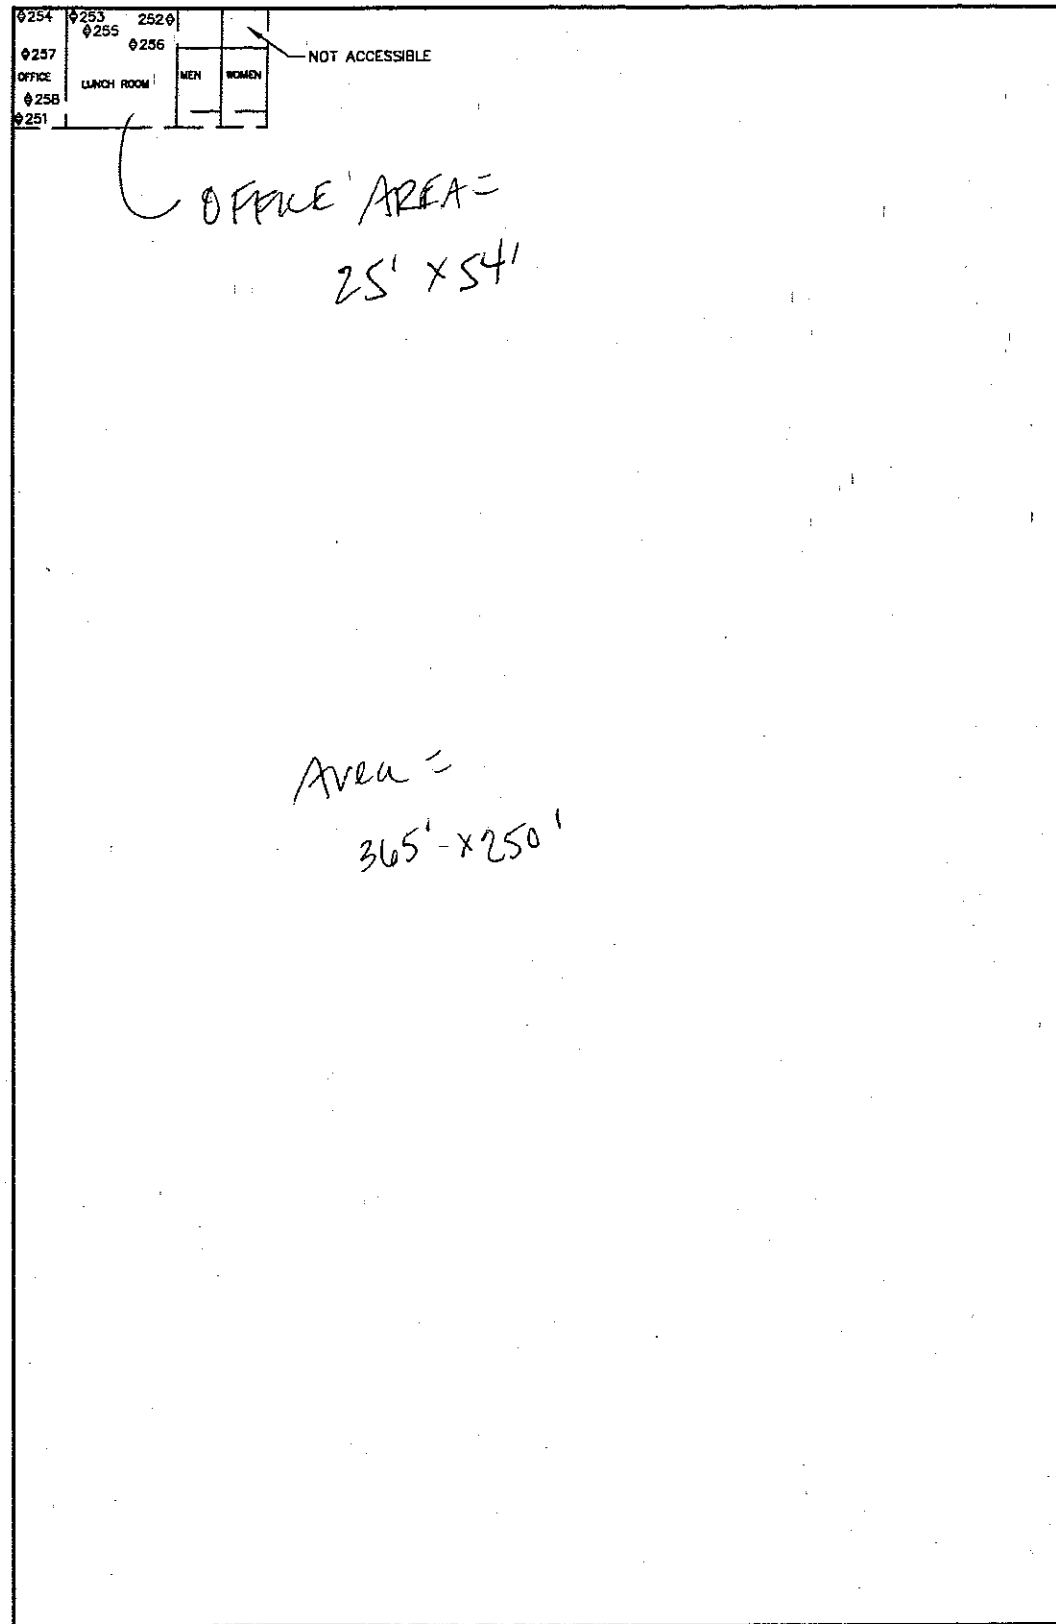
# FLOOR PLAN - WAREHOUSE 204

APPROXIMATE QUANTITY
1.	MATERIAL    Hard Fittings on Fiberglass LOCATION     Attic space in basement of office CATEGORY   Moderate concern	25 EA
2.	MATERIAL    Lay-in Ceiling Tile LOCATION     Throughout Warehouse office CATEGORY   Moderate concern	1,650 SF
3.	MATERIAL    Vinyl Floor Tile/Mastic LOCATION     Throughout first floor of office & stairwell CATEGORY   Moderate concern	3,130 SF
4.	MATERIAL    Stair Coving LOCATION     Stairwell of Warehouse 205 office CATEGORY   Low concern	50 SF
