Spill Prevention, Control, and Countermeasure Plan

**Port of Portland
Portland International Airport
Portland, Oregon**

Amended: November 13, 2024

Project No. M0232.17.073

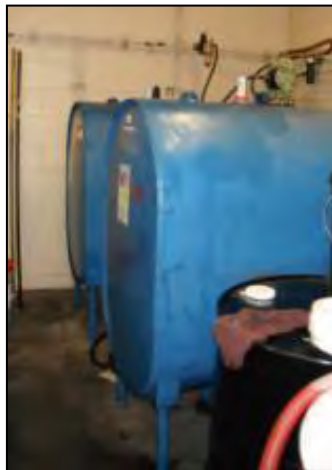
TANK ID: Tank 358
Also Known As: Tank PDX-11
Location: Maintenance Facility Oil Room
Shown On: Figure C-4
Contents: Automatic Transmission Fluid
Capacity: 275 gallons
Material: Steel
Type: Single-walled AST
Secondary Containment: Located within Facility Oil Room
Description of Drainage from Secondary Containment: Secondary containment provided by Oil Room - floor drain inside room is normally plugged and drains to oil-water separator and sanitary sewer.
Fault Analysis: Spills within the oil room would be contained by the room itself (floor drain is plugged and building structure would prevent spills from exiting building).
Engineering Controls: Visual fill gauge, tank sited indoors.
Corrosion Protection: None - AST indoors.
Integrity Testing: Not required for this tank. Follow STI SP001 Standard.
Inspections and Records: Monthly visual inspections, records kept minimum 3 years.
Security: AST is located inside the Maintenance Facility (kept secured when site not attended). Access to PDX is controlled by fencing and secure doors and/or gated entrances consistent with requirements for Homeland Security. Port provides 24-hour security monitoring of PDX. Tank is not located in areas accessible by public.

Other Applicable Spill Prevention Measures: Follow Tank Loading and Unloading Procedures (Appendix E). Spill kit materials available in vicinity of tank.
Spill Response/Cleanup Procedures. Follow Portland International Airport Spill Response Procedures (Appendix D)
Photograph:

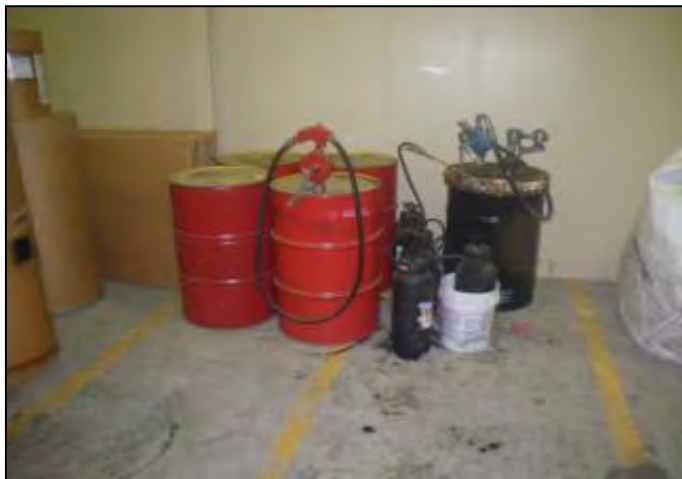
Photograph:

TANK ID: Haz Mat Storage Building Drum Storage

Location: Hazardous Materials Storage Building

Shown On: Figure C-4 (Hazardous Materials Storage Building)

Corrosion Protection: None - drums stored indoors.

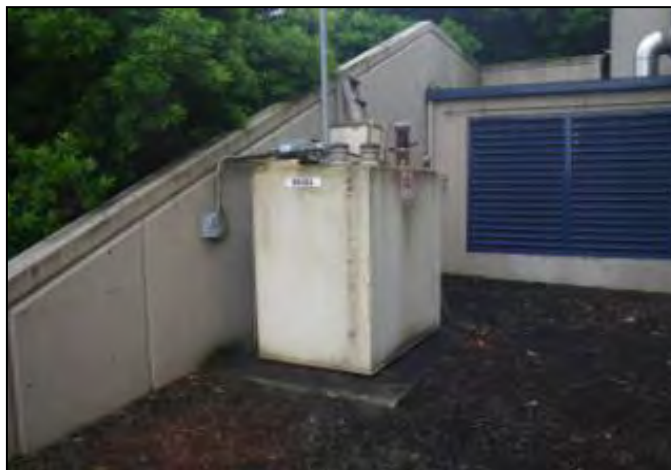
Photograph:

TANK ID: Tank 279
Also Known As: Tank PDX-9
Location: Maintenance Facility
Shown On: Figure C-4
Contents: Diesel Fuel
Capacity: 500 gallons
Material: Steel
Type: Double-Walled AST
Secondary Containment: Double-Wall
Description of Drainage from Secondary Containment: Intrinsic secondary containment does not drain.
Fault Analysis: Failure of primary containment will flow to the interstitial space of the double-walled containment system.
Engineering Controls: Visual fill gauges.
Corrosion Protection: Painted double-wall AST not in direct contact with ground. Above-ground piping.
Integrity Testing: Not required for this tank. Follow STI SP001 Standard.
Inspections and Records: Monthly visual inspections, records kept minimum 3 years.
Security: Access to PDX is controlled by fencing and secure doors and/or gated entrances consistent with requirements for Homeland Security. Port provides 24-hour security monitoring of PDX. Tank is not located in areas accessible by public.

Other Applicable Spill Prevention Measures: Follow Tank Loading and Unloading Procedures (Appendix E). Spill kit materials available in vicinity of tank.
Spill Response/Cleanup Procedures. Follow Portland International Airport Spill Response Procedures (Appendix D)

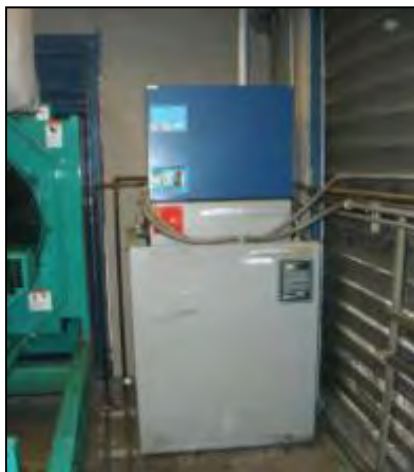
TANK ID: Tank 279 Ancillary Day Tank

Location: Maintenance Facility Emergency Generator Room

Fault Analysis: Failure of primary containment will flow to floor of the Emergency Generator Room.

Corrosion Protection: None - tank located indoors.

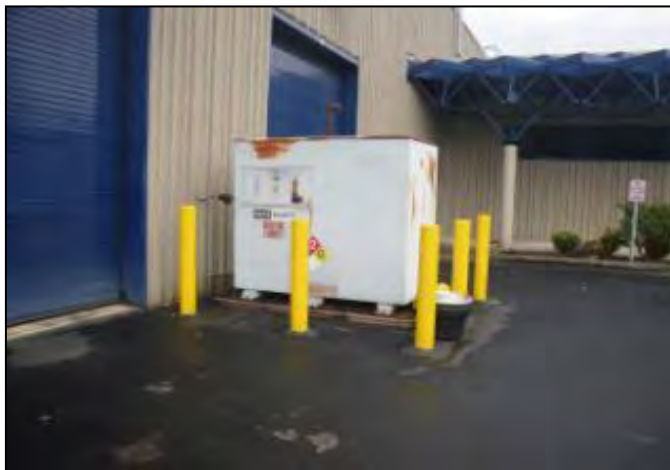
Photograph:

TANK ID: Tank 273

Location: Maintenance Facility

Fault Analysis: Failure of primary containment will flow to the interstitial space of the double-walled containment system.

Corrosion Protection: Painted double-wall AST not in direct contact with ground. Above-ground piping.

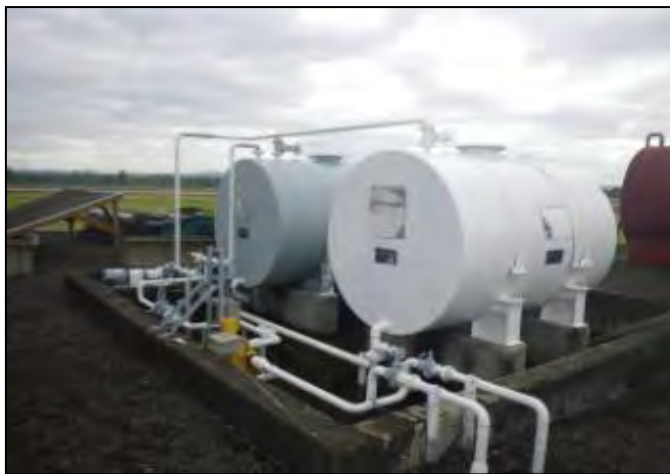
Photograph:

TANK ID: Tank 22

Location: Fire Training Facility

Fault Analysis: Failure of primary containment will flow to the concrete bermed containment vault which is connected via a valve to the adjacent oil-water separator system. The oil-water separator discharges to a nearby tank for collection and transport to sanitary waste drain or off-site management.

Corrosion Protection: Painted single-wall AST. Buried piping to have cathodic protection.

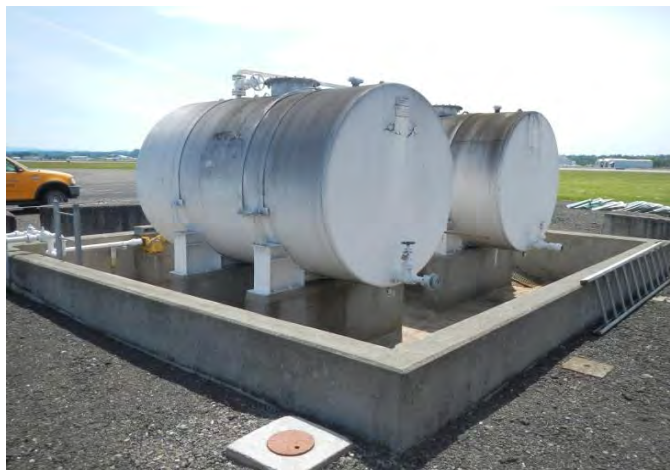
Photograph:

TANK ID: Tank 23

Fault Analysis: Failure of primary containment will flow to the concrete bermed containment vault which is connected via a valve to the adjacent oil-water separator system. The oil-water separator discharges to a nearby tank for collection and transport to sanitary waste drain or off-site management.

Corrosion Protection: Painted single-wall AST. Buried piping to have cathodic protection.

Notes: The ownership of Tank 23 is currently unknown and is being determined – but is being included in this SPCC Plan for completeness

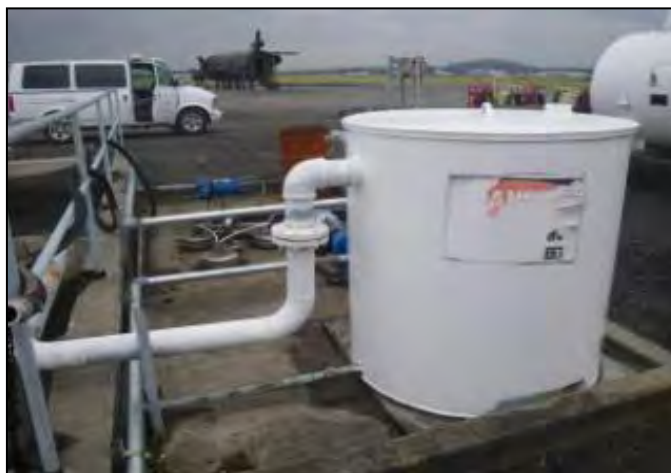
Photograph:

TANK ID: Tank 24

Fault Analysis: This tank is not currently in use. While operating, failure of primary containment will flow to the concrete bermed containment vault which is connected via a valve to the adjacent oil-water separator system. The oil-water separator discharges to a nearby tank for collection and transport to sanitary waste drain or off-site management.

Corrosion Protection: Painted single-wall AST not in direct contact with ground.

Notes: The tank is not currently in use and associated piping has been disconnected from service points.

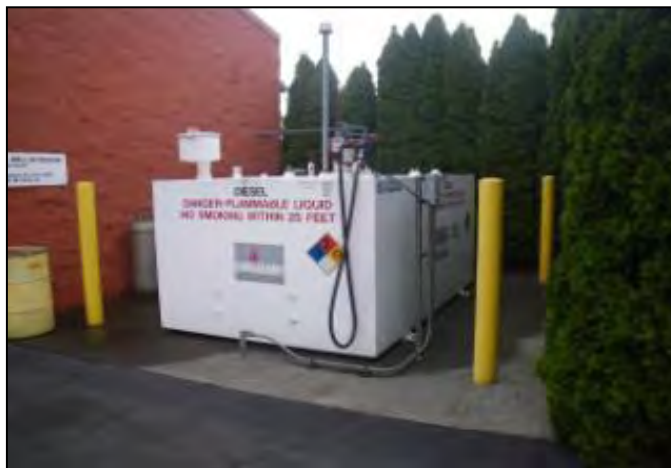
Photograph:

TANK ID: Tank 272

Fault Analysis: Failure of primary containment will flow to the interstitial space of the double-walled containment system.

Corrosion Protection: Painted double-wall AST not in direct contact with ground. Above-ground piping.

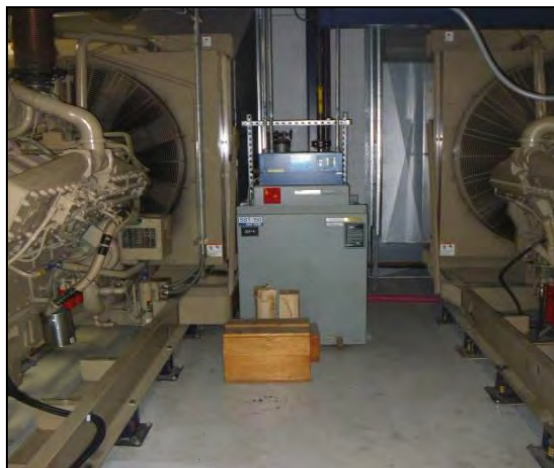
Photograph:

TANK ID: Tank 282

Location: Central Utility Plant, Emergency Generator Room

Corrosion Protection: None - AST indoors.

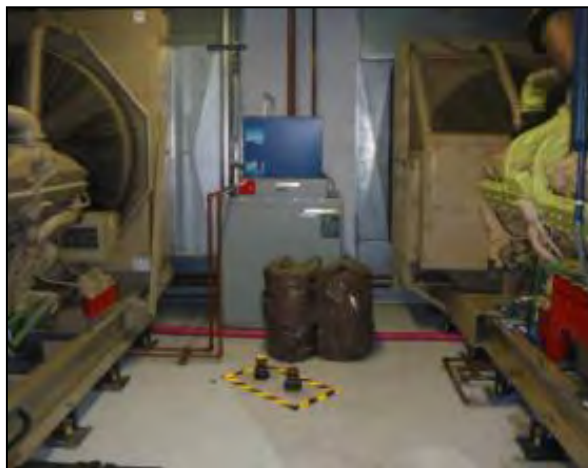
Photograph:

TANK ID: Tank 283

Location: Central Utility Plant, Emergency Generator Room

Corrosion Protection: None - AST indoors.

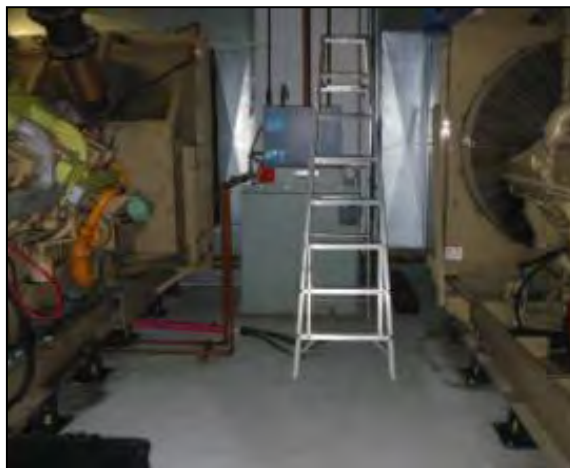
Photograph:

TANK ID: Tank 284

Location: Central Utility Plant, Emergency Generator Room

Corrosion Protection: None - AST indoors.

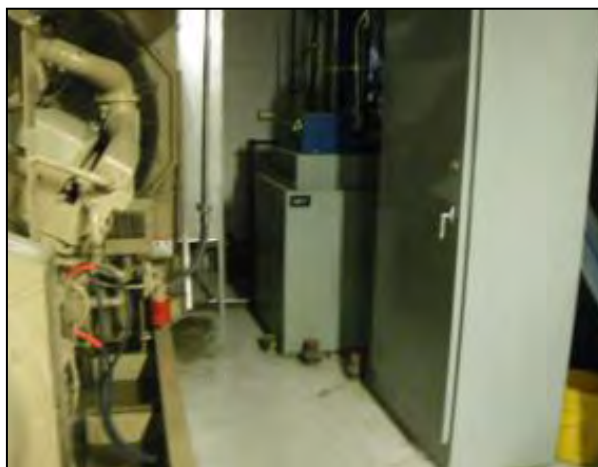
Photograph:

TANK ID: Tank 285

Location: Central Utility Plant, Emergency Generator Room

Corrosion Protection: None - AST indoors.

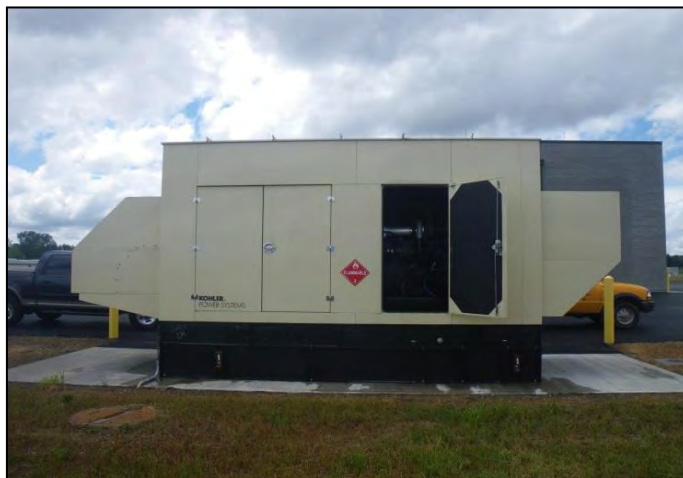
Photograph:

TANK ID: Tank 389

Location: Deicing Treatment Plant

Fault Analysis: Failure of primary containment will flow to the interstitial space of the double-walled containment system.

Engineering Controls: Visual fill gauges and interstitial leak detection.

Corrosion Protection: Tank not exposed to atmospheric conditions (in weather-rated enclosure) and not in direct contact with ground.

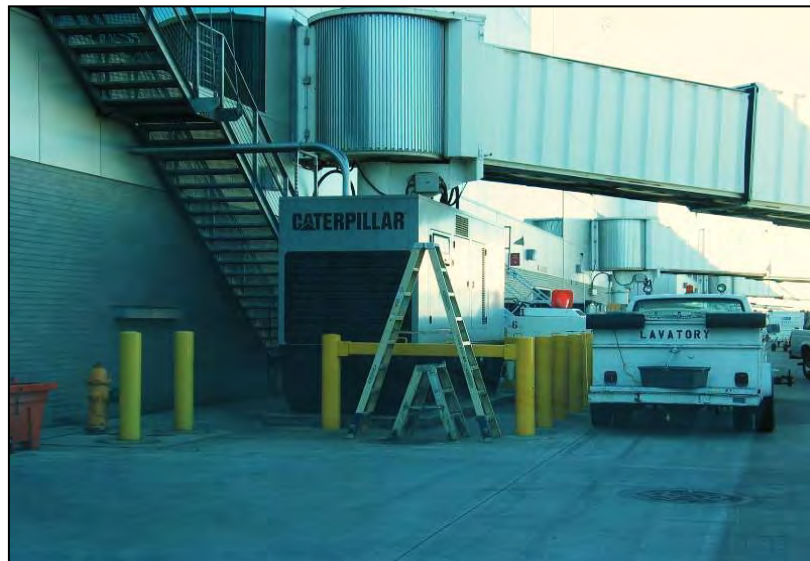
Photograph:

TANK ID: Tank 384

Location: North side of C Concourse

Fault Analysis: Failure of primary containment will flow to the interstitial space of the double-walled containment system.

Engineering Controls: Visual fill gauges and interstitial leak detection.

Corrosion Protection: Tank not exposed to atmospheric conditions (in weather-rated enclosure) and not in direct contact with ground.

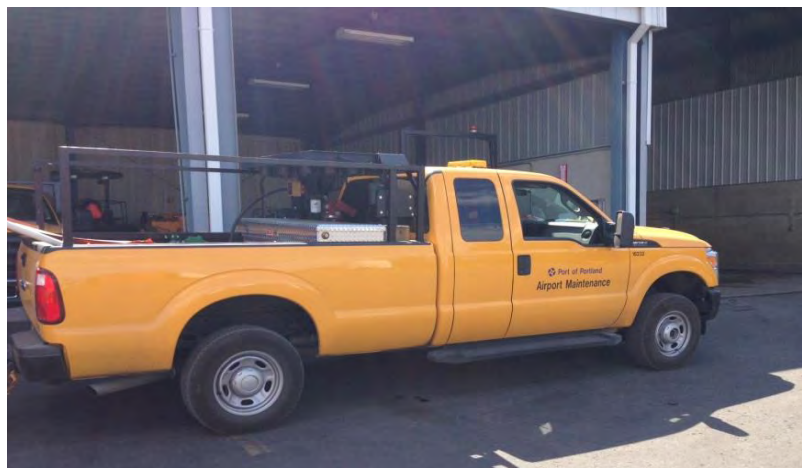
Photograph:

TANK ID: Vehicle 16232

Location: Service vehicle, parked in Equipment Storage Building

Corrosion Protection: Tank not in contact with the ground.

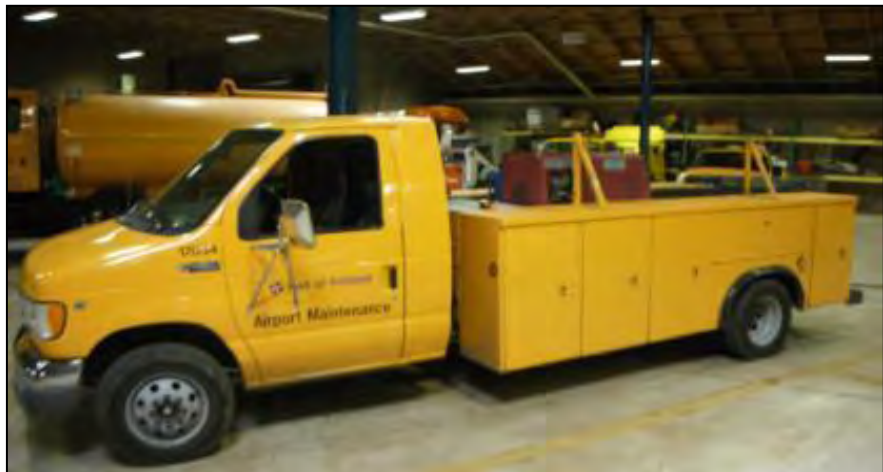
Photograph:

TANK ID: Vehicle 17034

Location: Service vehicle, parked in Equipment Storage Building

Corrosion Protection: Tank not in contact with the ground.

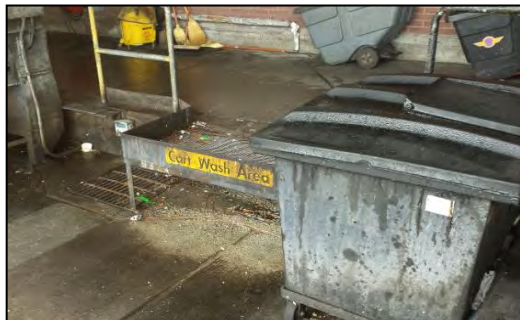
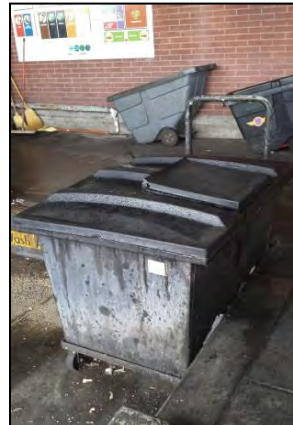
Photographs:

TANK ID: Main Terminal Food Wastes (Communal Grease Vat)

Location: Adjacent to Main Terminal (Outside of Food Court)

Corrosion Protection: Tank is not in direct contact with the ground.

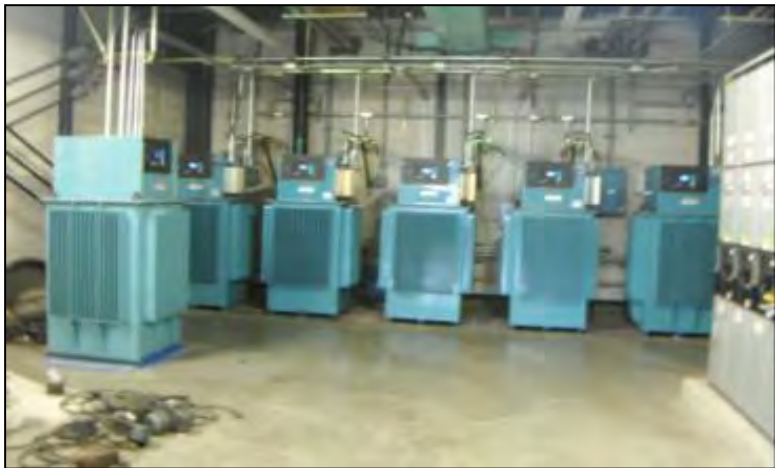
Photograph:

OIL-FILLED EQUIPMENT

PDX (CUP) Oil Filled Regulators (6)

Fault Analysis: Failure of primary regulator containment would flow to the bermed area of the Oil Regulator room and would be contained fully within the building. Containment volume is well in excess of needed volume.

Corrosion Protection: N/A (oil-filled equipment; not oil storage); located indoors.

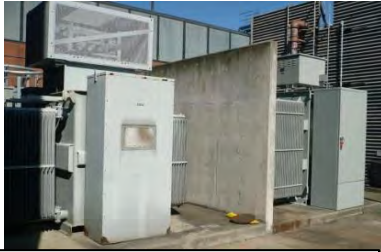
CUP North Courtyard:
1359002345 and 1359002346

Fault Analysis: Failure of primary transformer containment would flow to ground in vicinity of transformer. Transformers other than 1359002345, 1359002346, 1359002365, and HBB5445-001T are indoors or have containment curbs. Flow in vicinity of remaining transformers serviced by storm drain outfitted with insert maintained in the closed position.

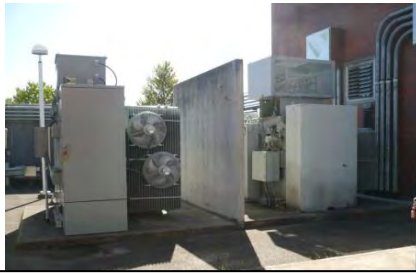
CUP South Courtyard: HBB5445-001T
and 1359002365

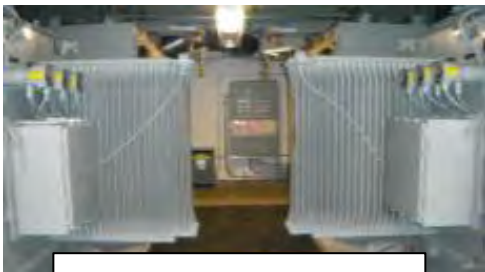
Concourse E at gate E-1
Rm. E1000: TE-A and TE-B

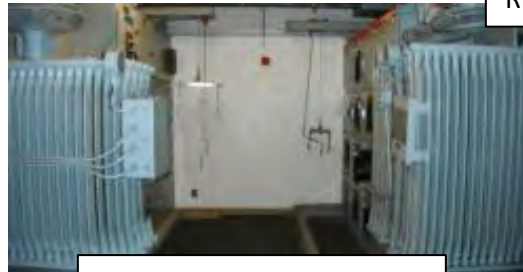
Concourse D at Gate D-9
Rm. D1620: TDA and TDB

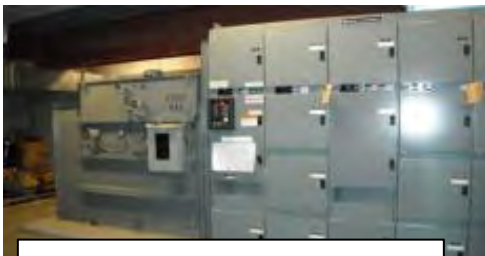
Parking Structure 1st Flr. SW
Corner RM 1205A: P-1A

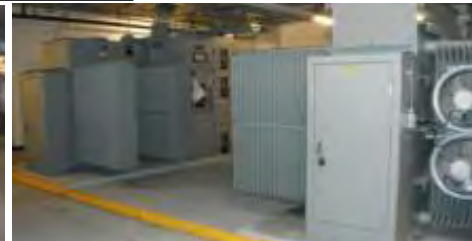
Concourse C, West at Gate C-15,
Rm. C1080: TCA and TCB
